# Dam Inspection Report and Action Plan

Project: 1075 Horseshoe Bend Road Torquay  
Report No: AGTE20249-1

21 October 2020

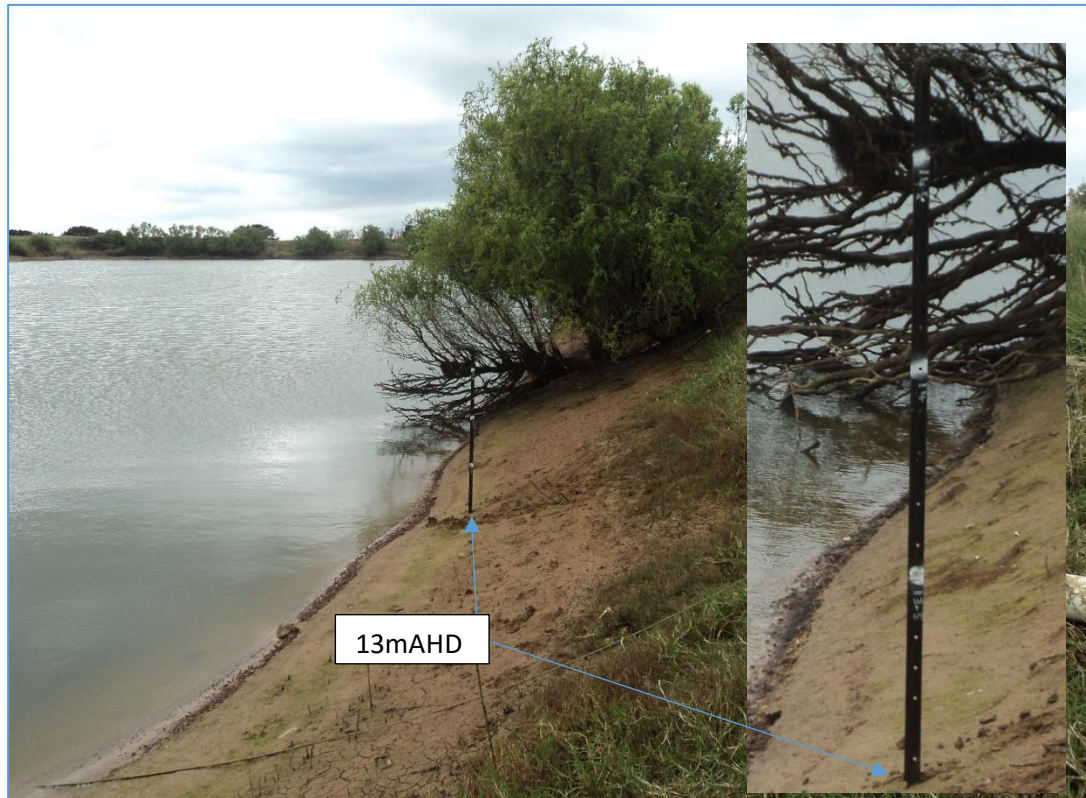
Figure 1 Water Level Marker

Water level marker is installed as shown in Figure 1. Due to safety reason installation is at 13 mAHD and the arrangement is being made to lower the reservoir water level and carry out the installation at RL12 mAHD.

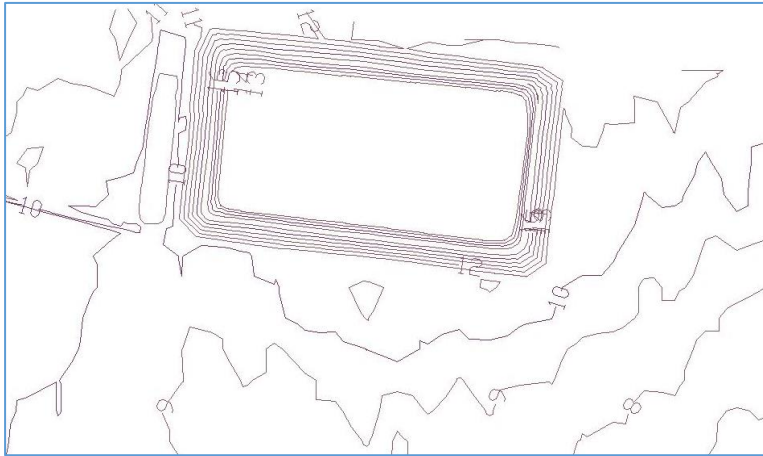
Figure 2 Elevation Contours around Dam Site

- Immediate Risk due to Flooding Risk (Spillway Requirement): Figure 2 and 3 show elevation contour map and the estimated flood levels of the area. It can be seen in Figure 2 that the embankment is at least 5m above surrounding ground with relatively far distance from 1% AEP flood zone. This means the very low catchment size with embankment crest being above significant flood events. Therefore, the overtopping of embankment is unlikely. Nevertheless, this will be further assessed during the comprehensive safety review considering more significant flood levels over 1% AEP.

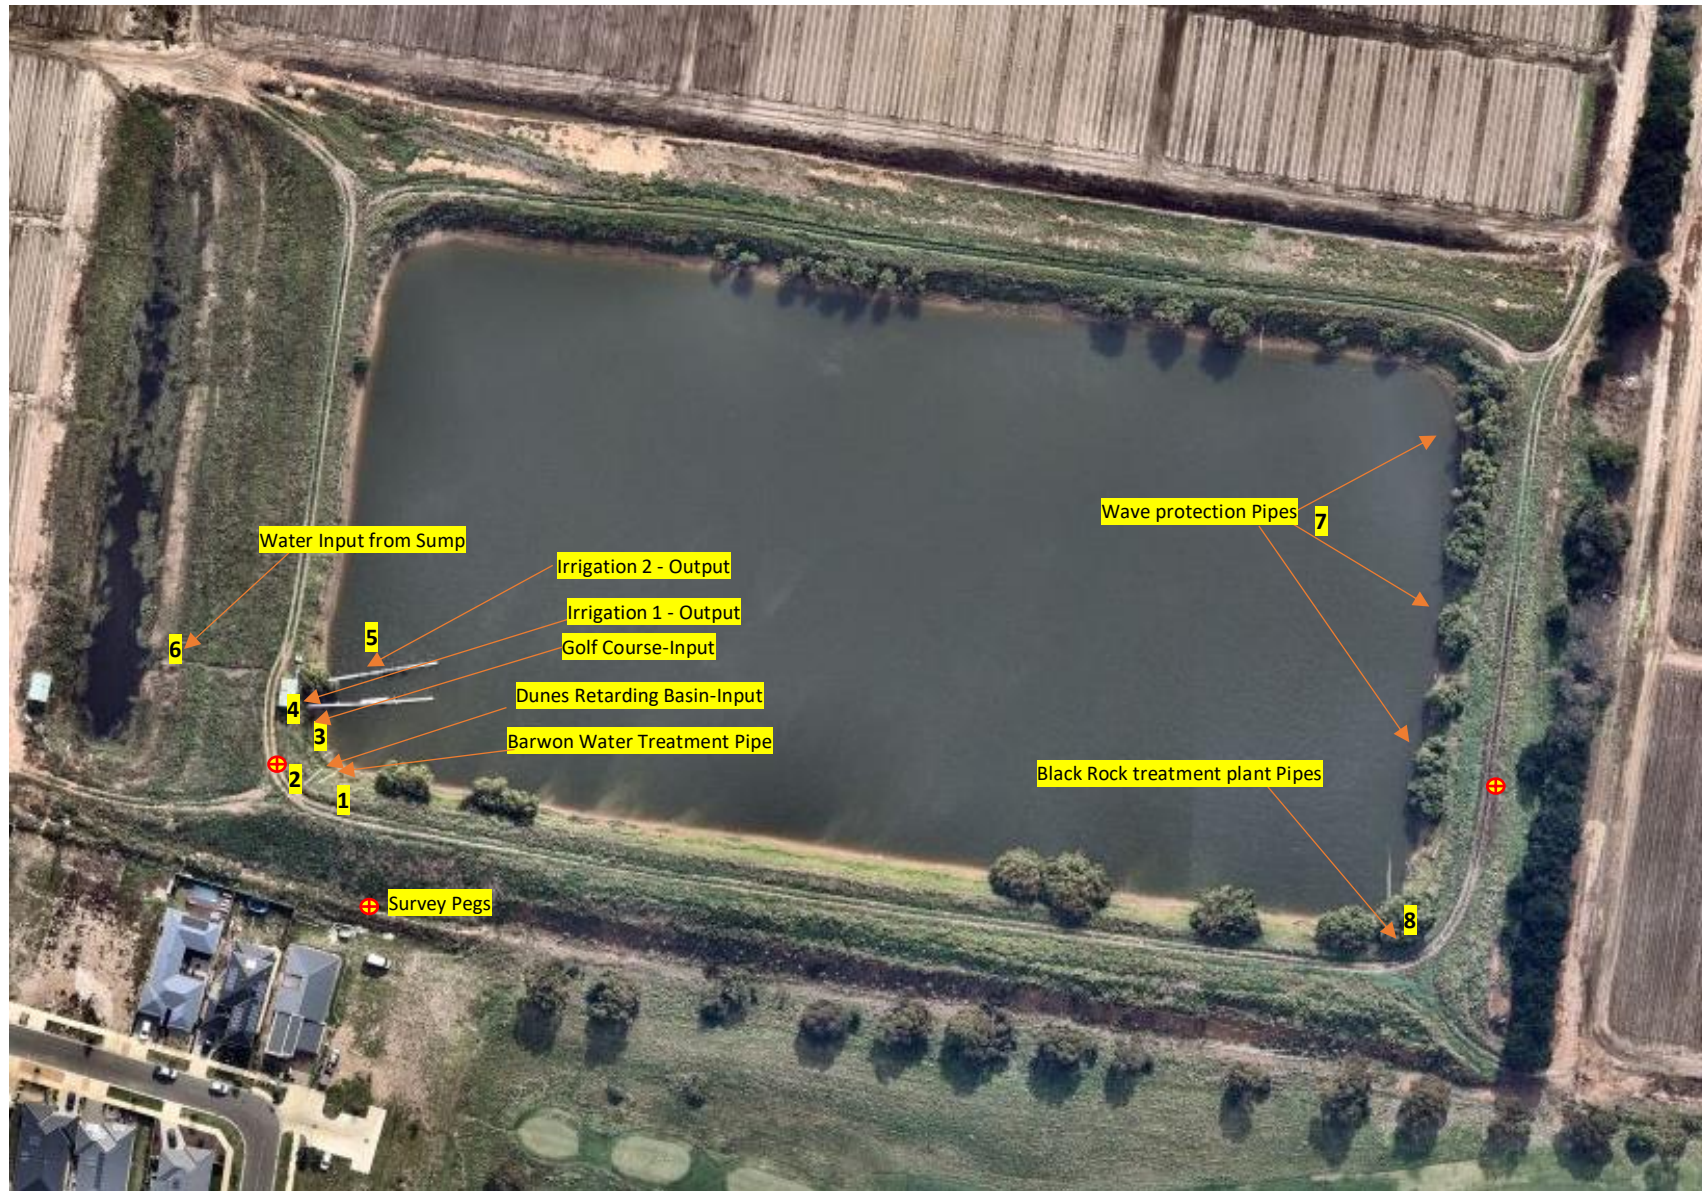
- Inlet and Outlet pipes around and inside embankment was inspected and the details is presented in Appendix A. All pipes are currently above the operating water level except the pipe from the flood sump immediately west of the dam.
- The pipe that was concluded to be the cause of leak, is part of Barwon Water’s decommissioned treatment plant and is capped off following the leak incident. A meeting is organised with Barwon Water to discuss removal of the pipe.
- The water level at reservoir is to be operated at 12 mAHD. Fluctuations to RL12.5mAHD has been observed in the absence of depth marker and is prevented after the marker installation.
- Embankment surface is mostly visible for safety inspections. A small area at southeast corner where the Black Rock Treatment Plant inlet pipe are located requires clearance the vegetation.

**Figure 1** Old Treatment Plant ran by Barron water. Plant decommissioned but pipe was not properly decommissioned. The pipe was submerged during the leak and was concluded to be the path for leak. The blue cap was installed after the leak incident.

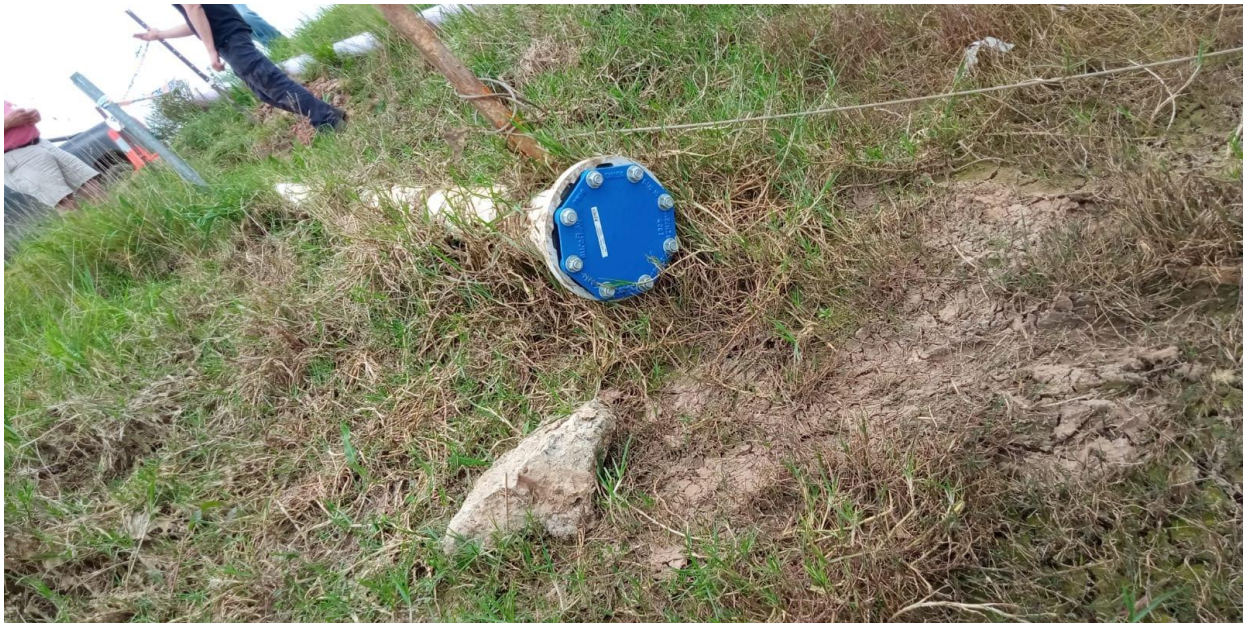
**Figure 2** The Dunes retarding basing. Input water to reservoir. Flowmeter Installed

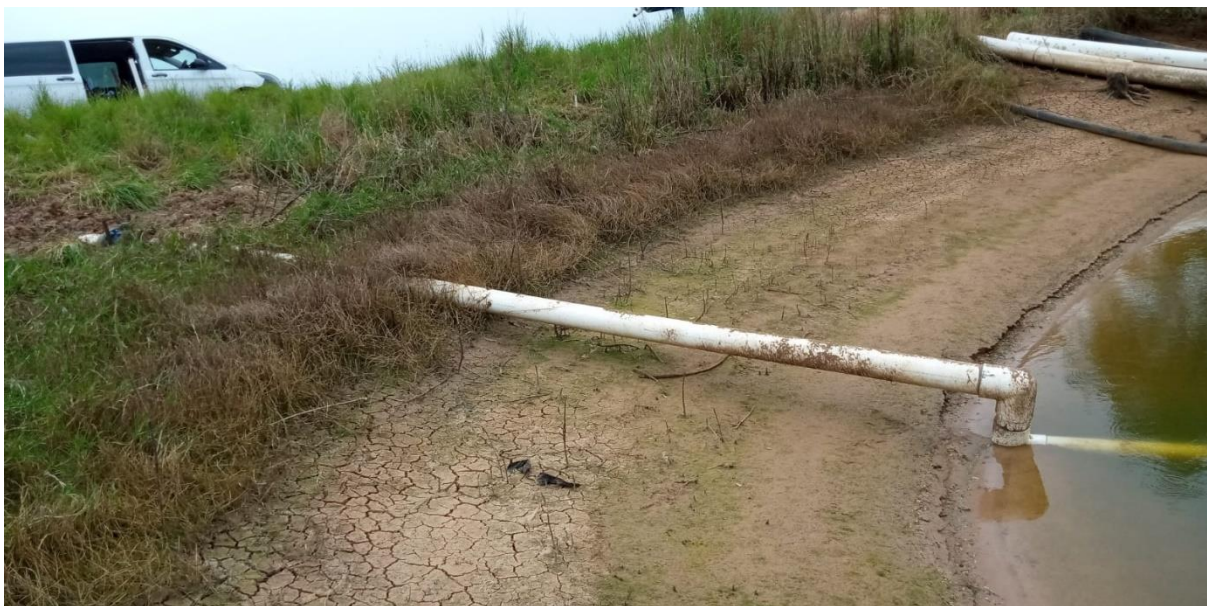
*Figure 3 Retarding basing, 500m away football field*

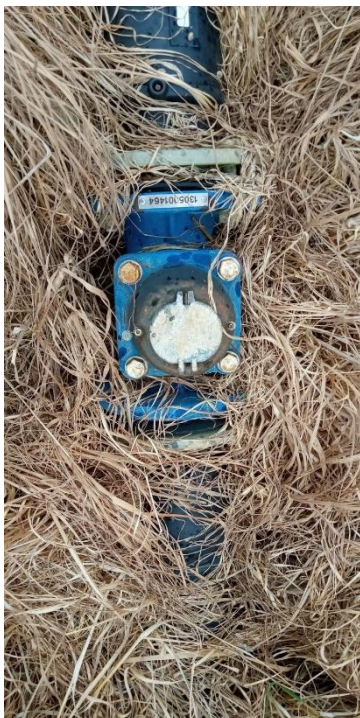
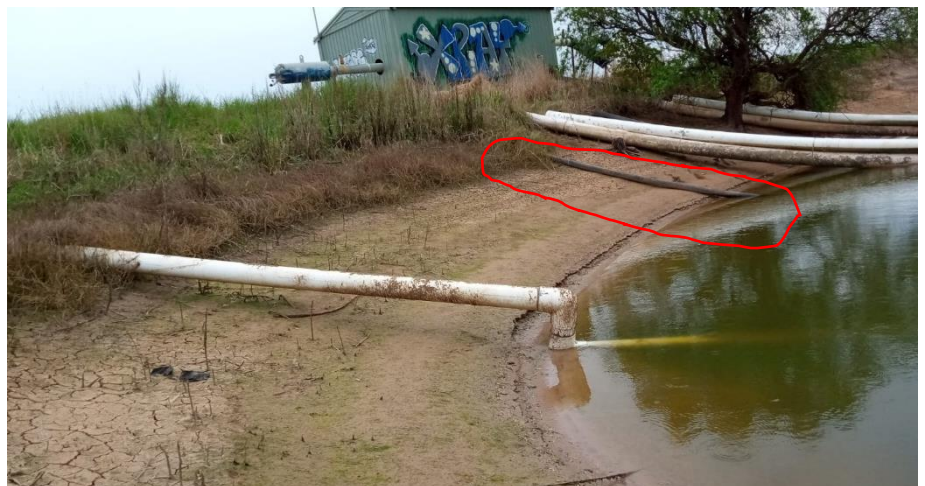
**Figure 5 Irrigation 1 - Water output - flowmeter not installed**

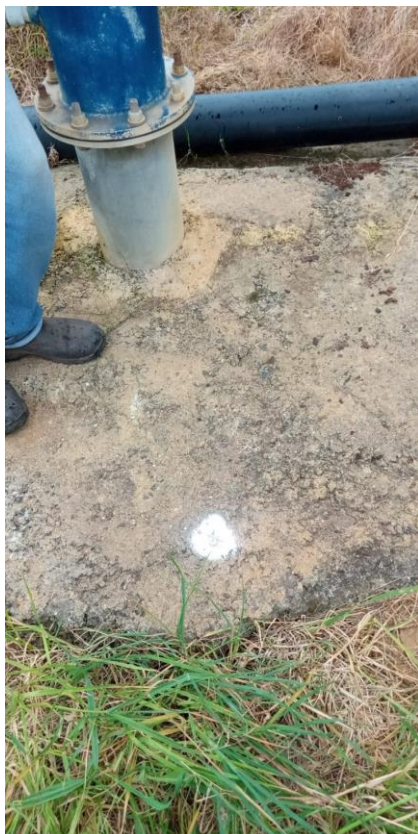
*Figure 7 Output to golf course Flowmeter installed*

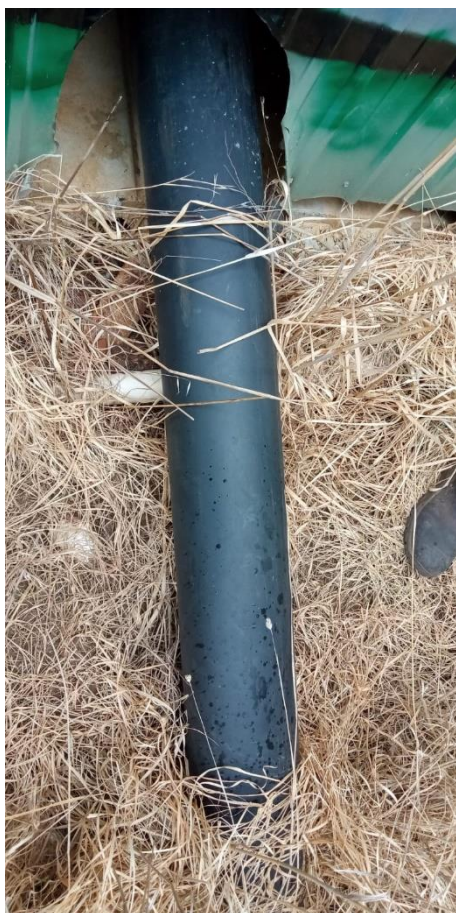
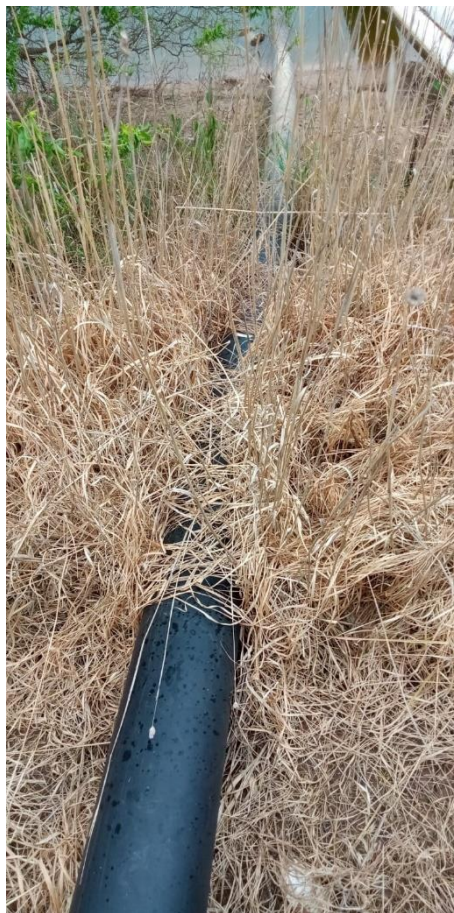
*Figure 8 Irrigation 2 Flowmeter not installed*

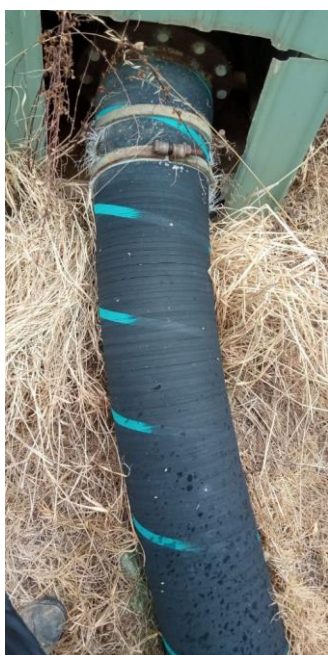
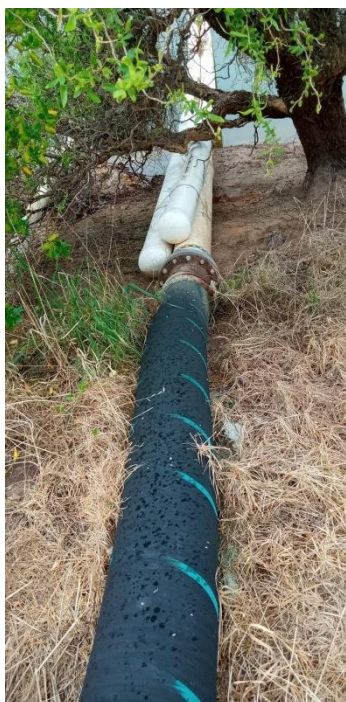
*Figure 9 Water from Sump next to dam input to reservoir*

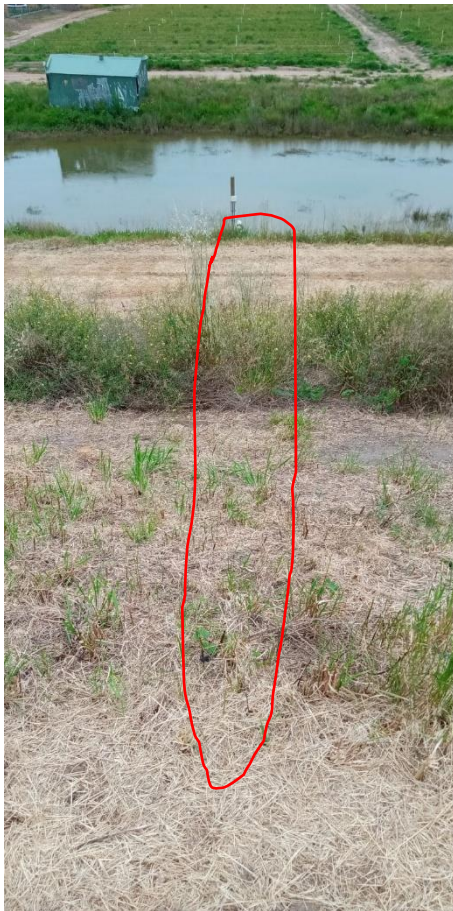
*Figure 10 Pressure Relief and Other Controls Next To Pump House On Crest*

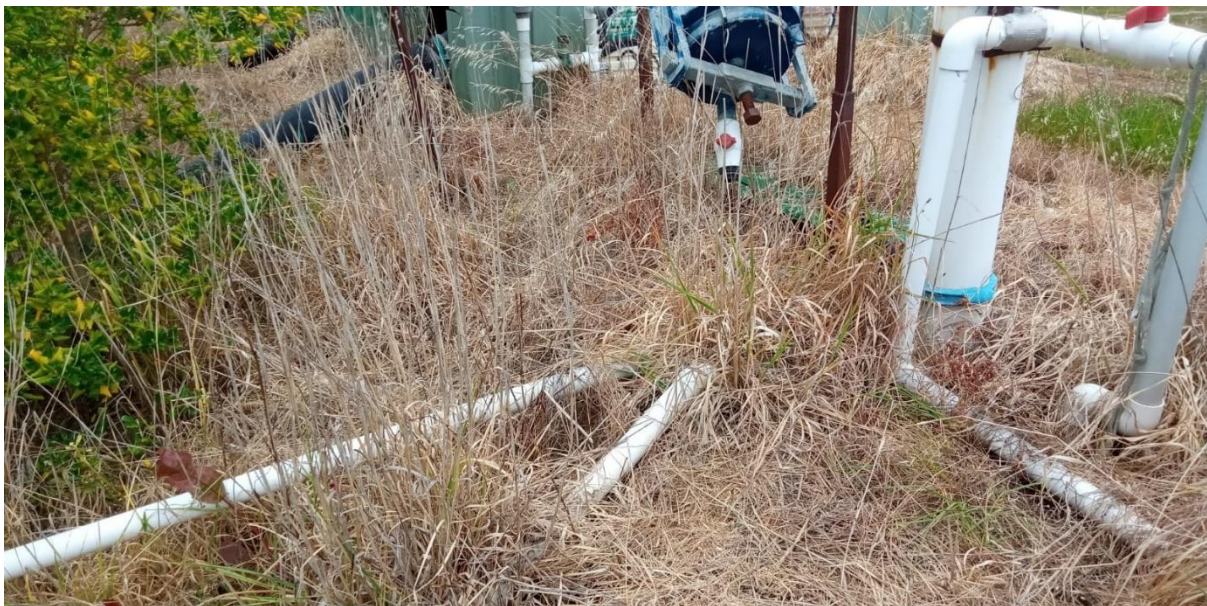
**Figure 11** *Irrigation 3 - Additional outlet for less flow volume*

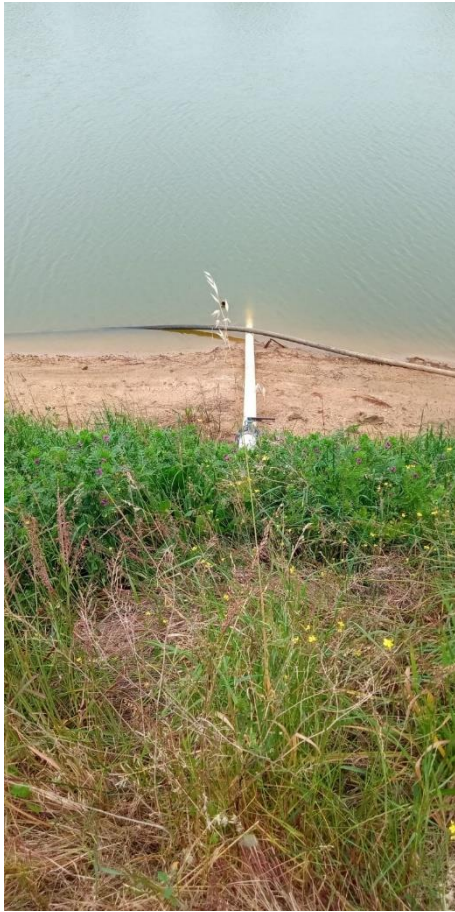
**Figure 12** *Northeast bank – Black Pipe for erosion reduction of Wave Action*

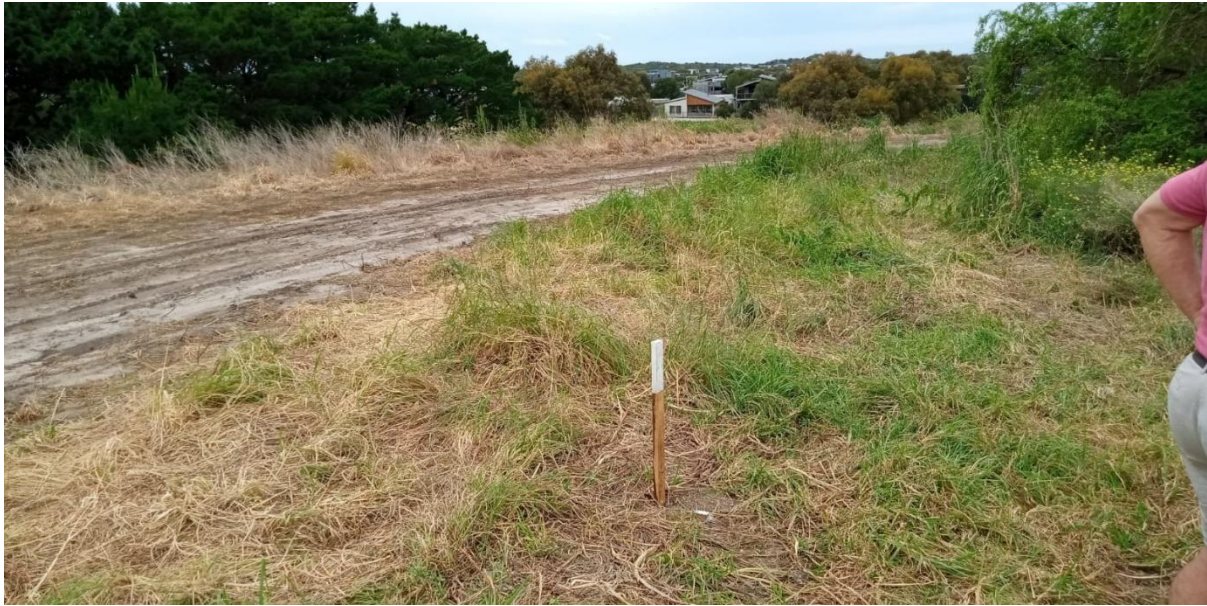
**Figure 14** Input From Black Rock treatment plant Class C Water
