# Dam Safety Review

Project: Torquay Farm Dam – Horse Bend Shoe Road  
Report No: AGTE20249-3 Rev 1

30 January 2021

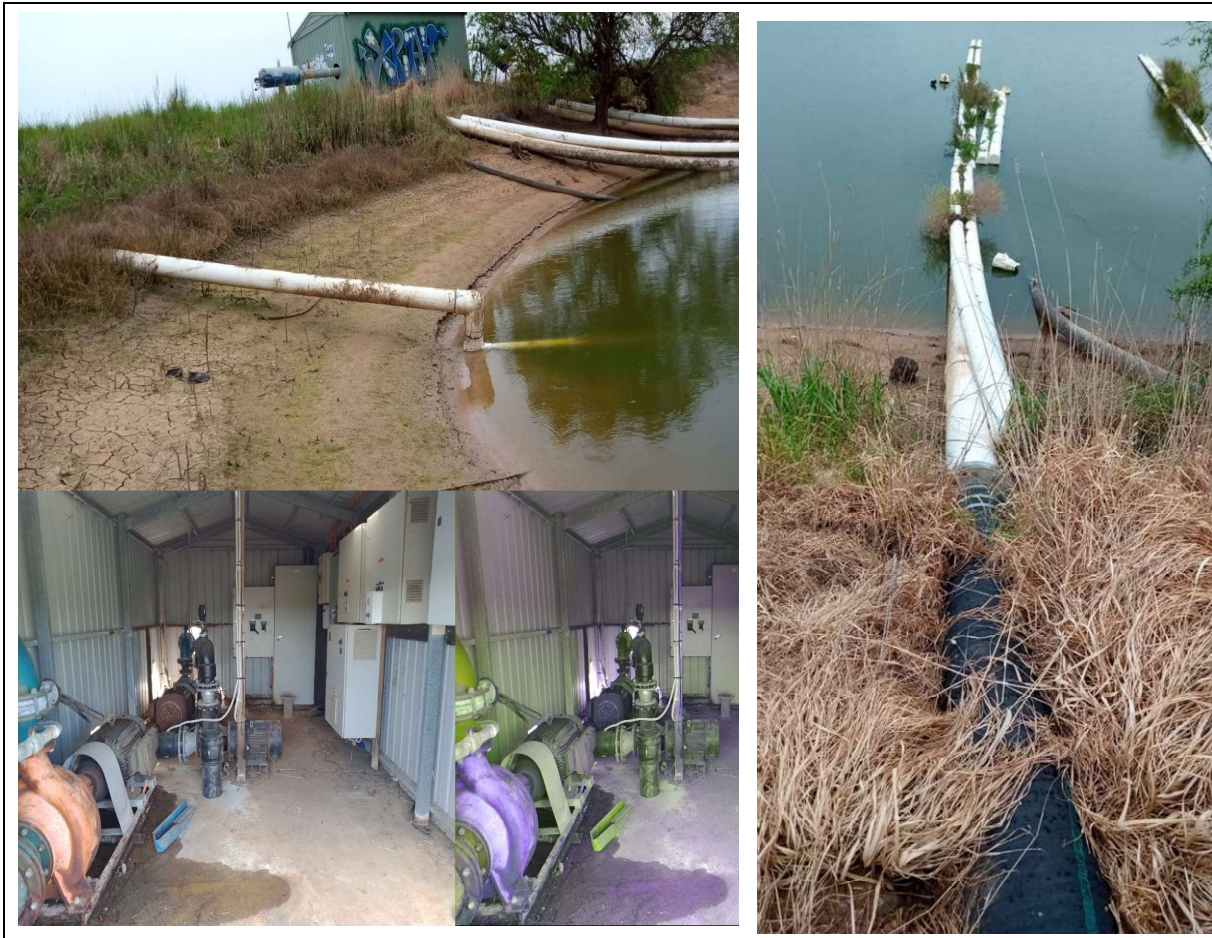
*Plates 1 and 2: Inlet and Outlet Pipes and Pump House Arrangement*

Several inlet pipes were observed in front of the western embankment. The water is sourced from the Black Rock Treatment Plant which transfers treated water into the dam, stormwater from the Sands golf course and from 3 other locations away from the dam. The flow of water can be stopped at any time using the valves in the pump house.

No evidence of seepage or leakage of the dam was observed in 2017. A recent incident occurred in October 2020 with water leaking into two neighbouring properties through a decommissioned pipe. The pipe was used prior to 2015 to transfer the water to a treatment plant immediately southwest of the dam. After the decommissioning of the treatment plan the transfer pipe was left inside the embankment without any capping. After raising the reservoir water level, the pipe collar was submerged directing the reservoir water into the neighbouring properties. This was identified by SRW and the pipe was capped.

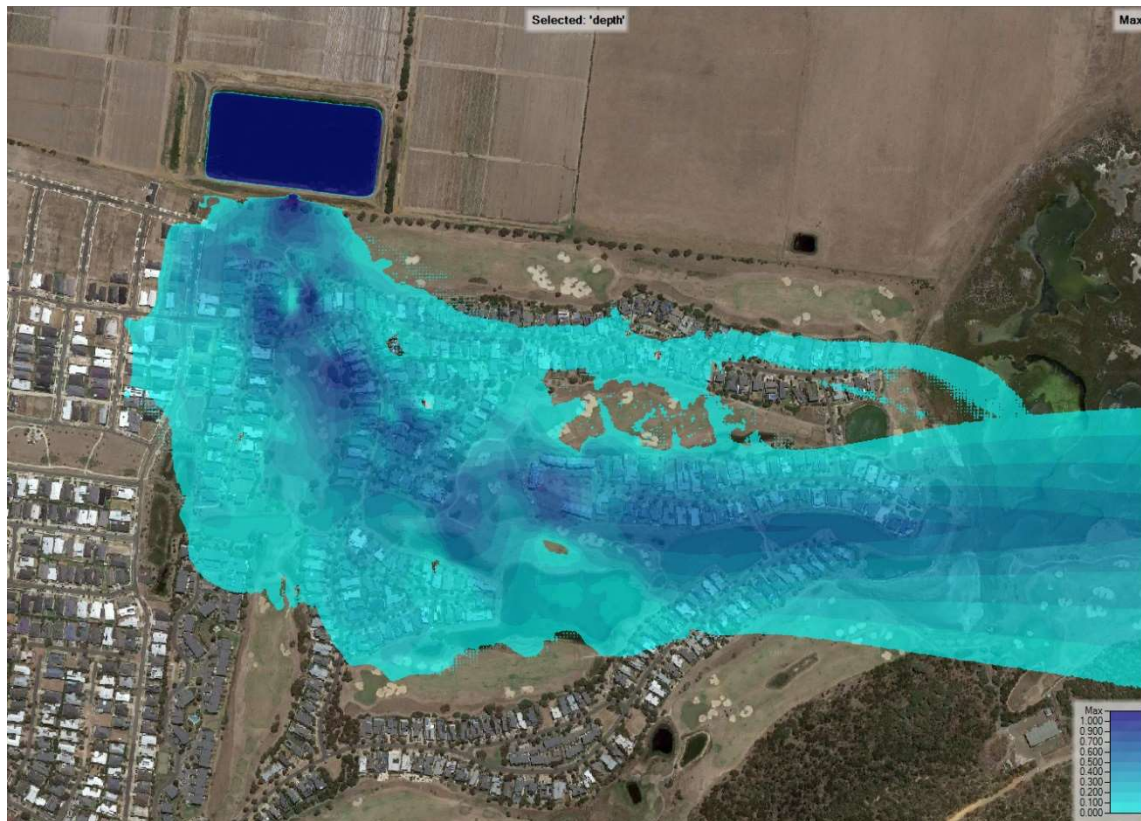
Based on the above map there are between 400 to 600 properties that could be affected due to a dam break with a reservoir water level of RL14 mAHD.

**Figure 2 –Maximum Depth of Flood Water Level (metres)- Reservoir Water Level at RL14**

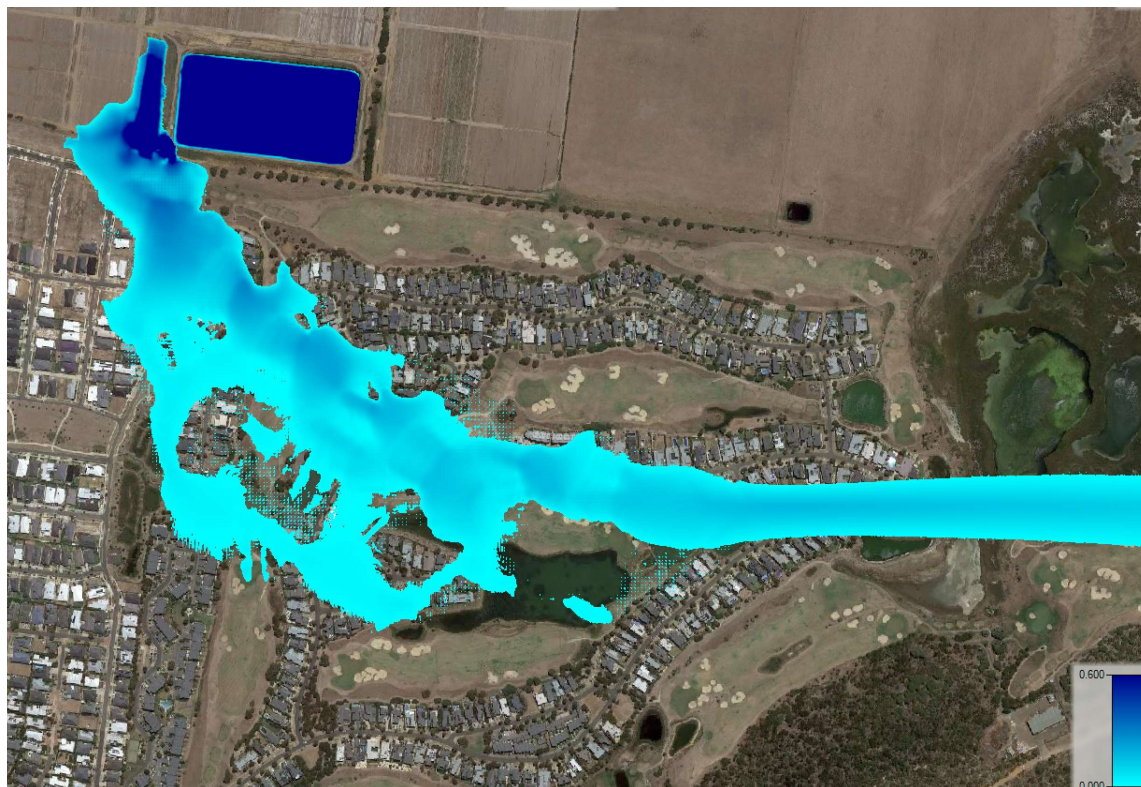
**Figure 3 –Maximum Depth of Flood Water Level (metres) - Reservoir Water Level at RL12**

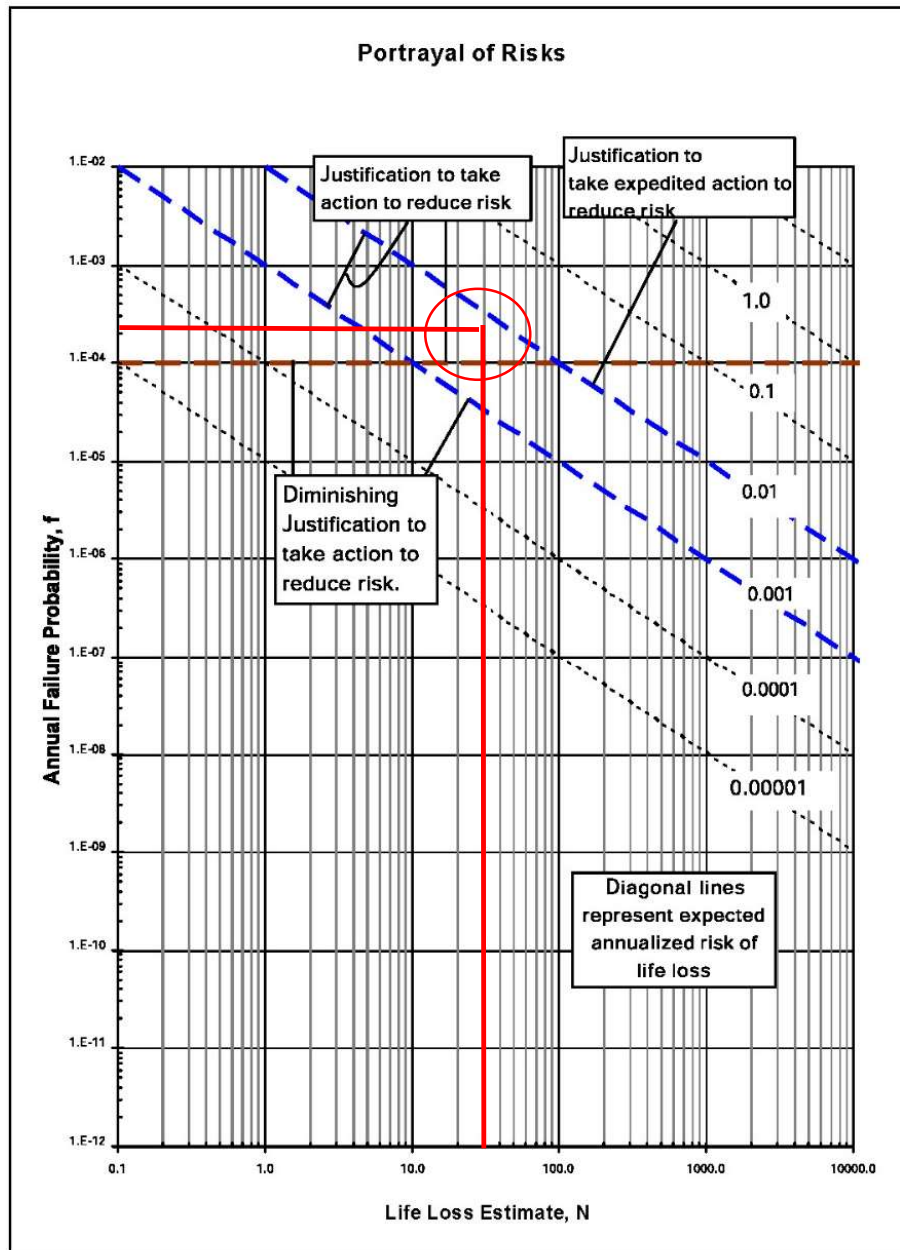
As shown in Table 8.2.2 the highest piping risk is in the embankment and calculated to be  $2.46 \times 10^{-4}$  after 5 years of operation. USBR provides the following graph to provide guidance on relating the risk and potential loss of life to the actions required to improve the safety of the dam. With a potential loss of life of 30 or more and considering the probability of embankment piping failure of  $2.46 \times 10^{-4}$  the action is deemed to be between “Take Action” and “Take expedited action” to reduce risk.

**- The f-N Chart for Displaying Probability of Failure, Life Loss, and Risk Estimates**
