Dam Inspection Report

Project: 1075 Horseshoe Bend Road Torquay
Report No: AGTE20249

9 October 2020

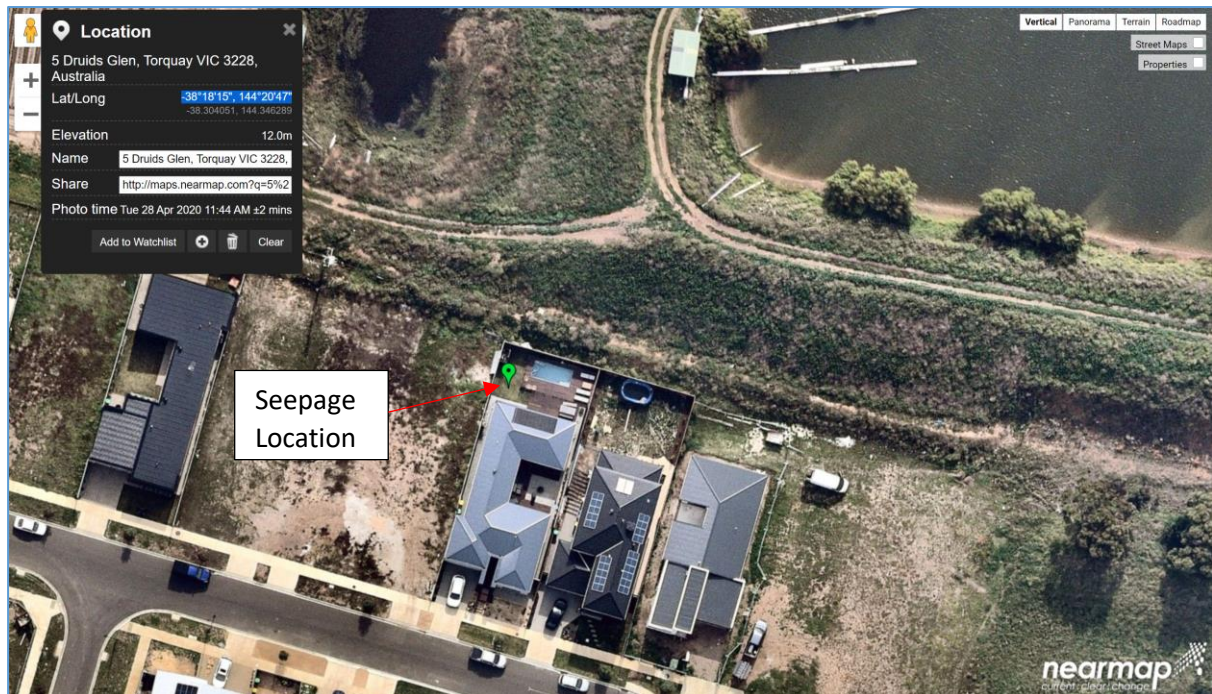
- address concerns raised for the dam safety after seepage observed in the backyard of the property located immediately to the southwest corner of the dam (-38°18'15", 144°20'47").
- Address actions raised in the letter from Southern Rural Water (SRW) dated 6th October 2020, a direction under Section 80 of the Water Act 1989 (the Direction).

Figure 1 Observed Seepage Location Relative to Dam
