## Arboricultural Impact Assessment

Tree/s Location: 1075 Horseshoe Bend Road, Torquay, 3228

Completed for: Santo Spirito Flowers

Inspection date: 28<sup>th</sup> January 2021

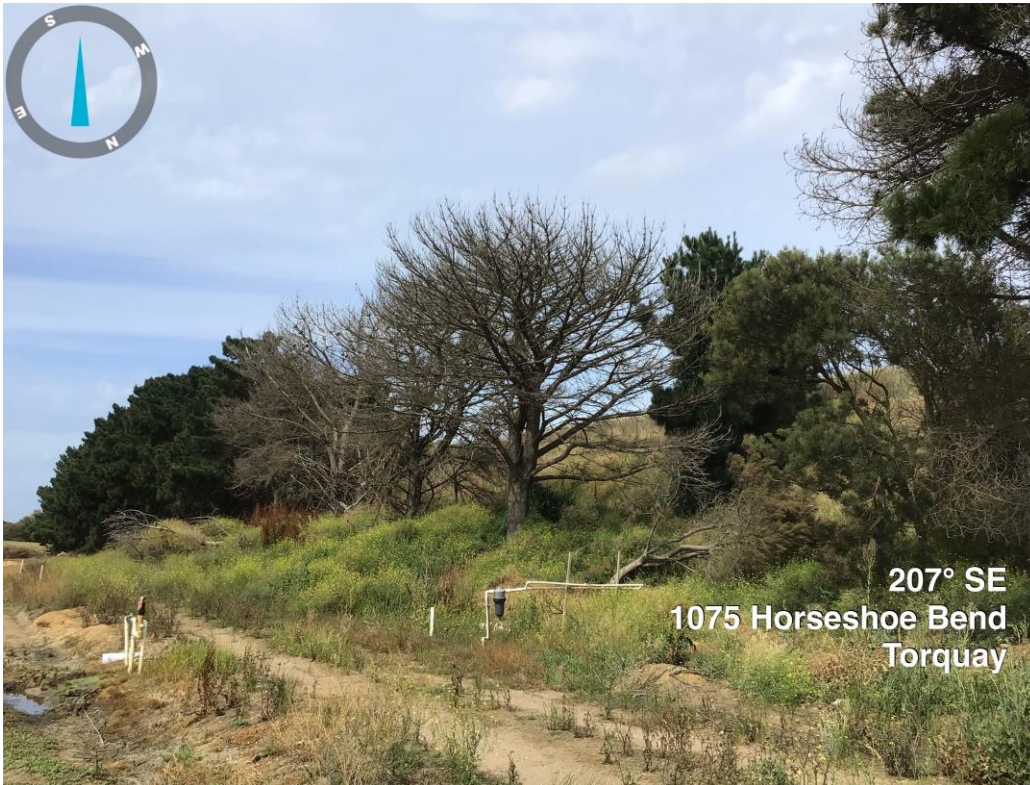
All dead *Pinus* and those in decline have had fill (mud) dumped around their trunks and critical root areas. This appears to have been dumped over the dam wall and has slid down the bank. Approximate depth of fill appears to be 0.6-1m on average. Live trees do not have fill at base.

Outer dam  
wall showing  
dead Pines  
and live trees  
either side.

*This is what has occurred on this site.* Excess fill has been dumped over the dam wall and has run downhill to rest among the root zones of multiple Pine trees. Given it was likely wet soil when applied, this fill has effectively blocked any oxygen from reaching the roots, as well as preventing future surface water uptake. This has caused six Pines to die, while others are heavily declined and will likely die also.

5. We recommend fill should not be placed near the root zones of any trees on site in the future. This is extremely detrimental to tree health.
6. We also recommend any juvenile Pine trees that have self-seeded on the dam wall (see image page 9) should be removed. These trees do have the potential to damage the dam wall as they grow larger.

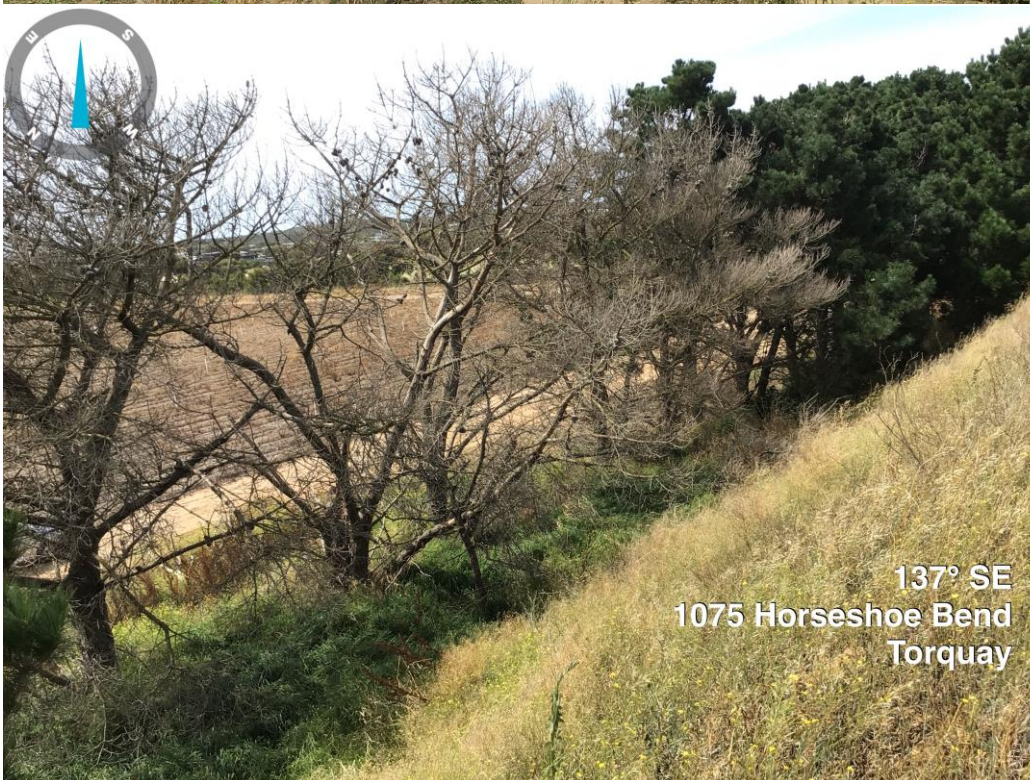
View from  
top of dam  
wall toward  
dead Pines.

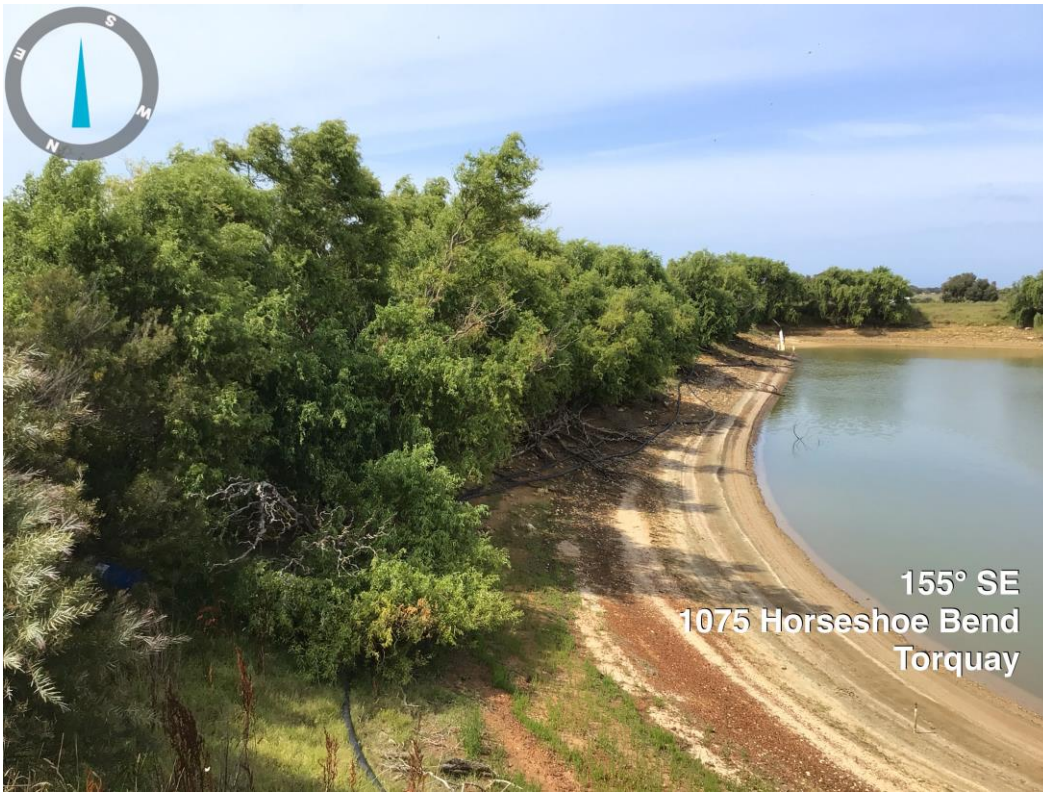
Trees inside the dam wall were healthy *Salix x pendulina* (Weeping Willow). These are a weed species commonly found around waterways in Victoria.

Inner dam  
wall lined by  
Willows.

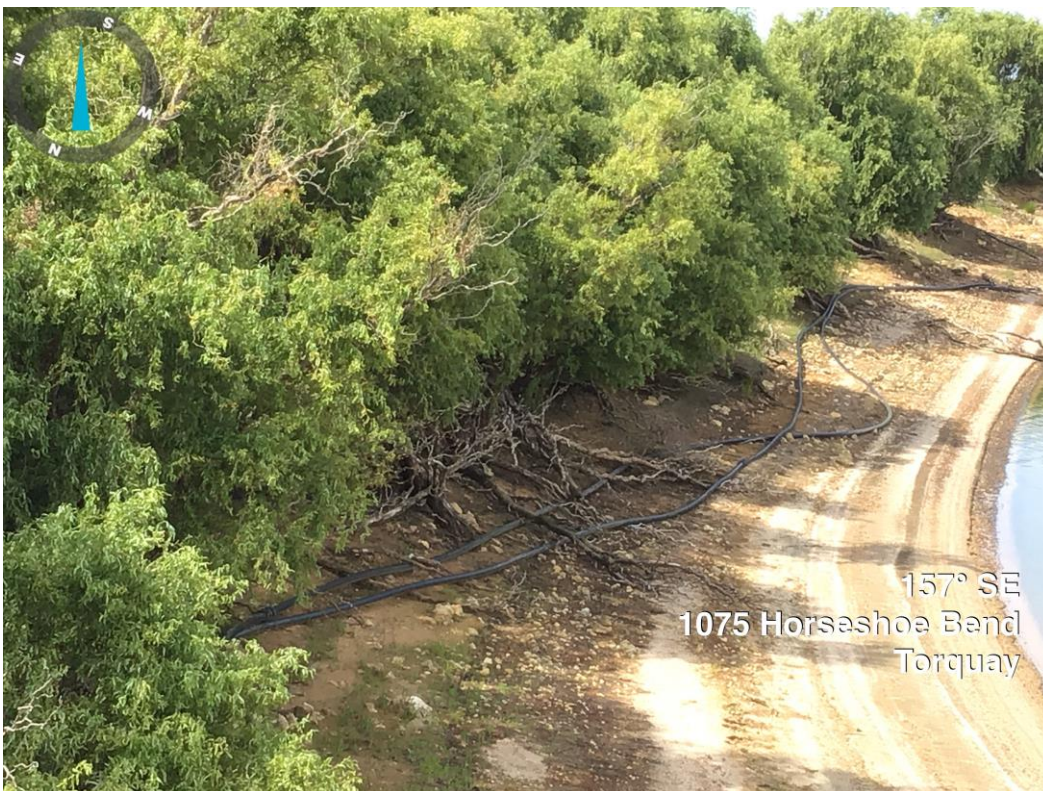
Close up of  
Willows showing  
extensive surface  
roots.

Keeping this in mind, it is unlikely that the roots of any of the Pine trees or Willows lining this dam wall would seek to burrow *into* the dam wall itself. There is insufficient oxygen and water available at such a depth underground - it does not make any sense for the tree to develop its roots in this manner.

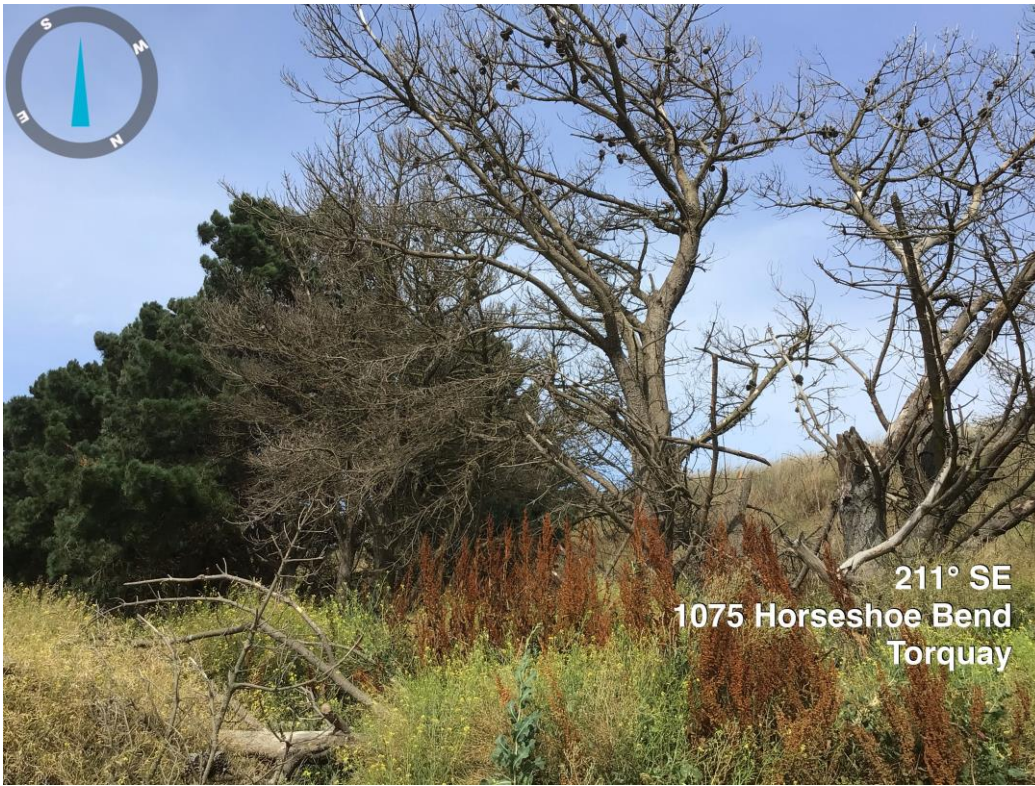
Weeds growing  
on mounded  
soil beneath  
dead tree.

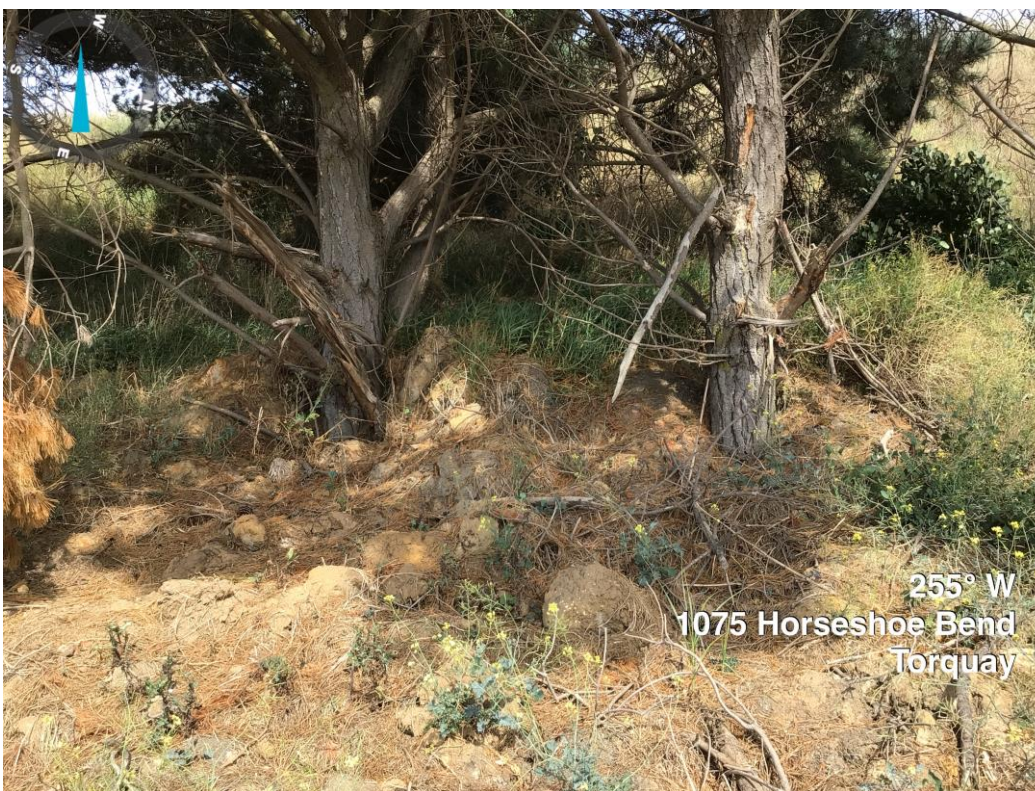
Soil/fill dumped  
around root  
zone of Pines.
