**RE: Panel presentation from Vicky Muis-Khoury (63 Pintail Drive)**

**Application to Alter an existing dam at 1075 Horseshoe Bend Road, Torquay**

**Project 87104.00**  
**December 2020**  
**R.001.Rev0**  
**GG/SG**

**Preliminary Geotechnical Investigation**  
**Pintail Drive Investigation**  
**61 Pintail Drive, Torquay**

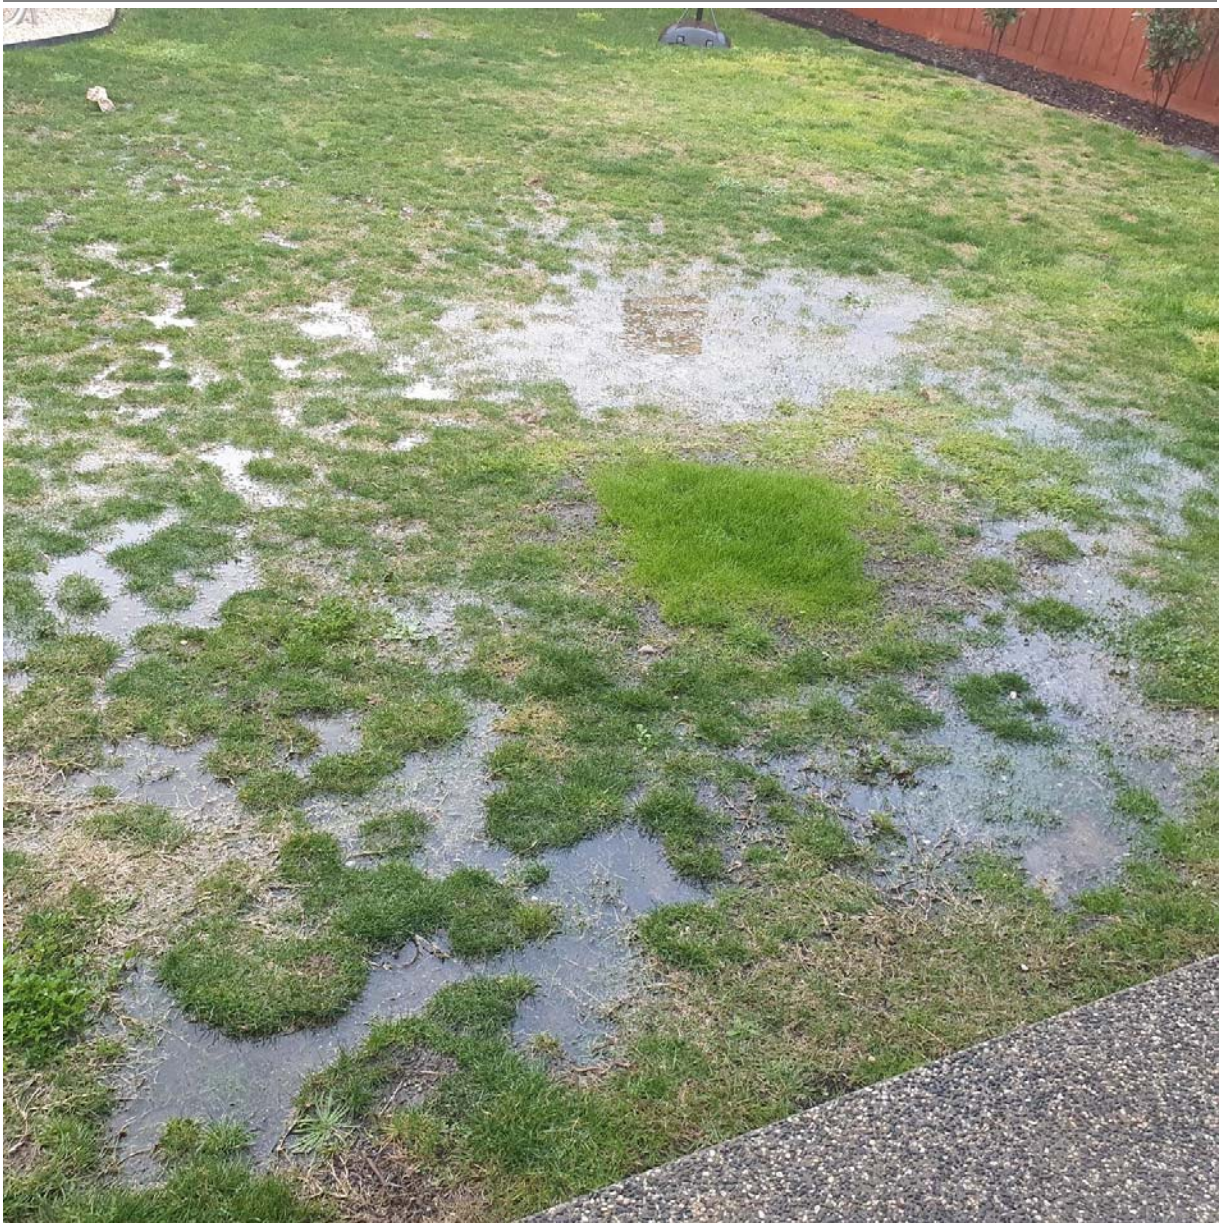
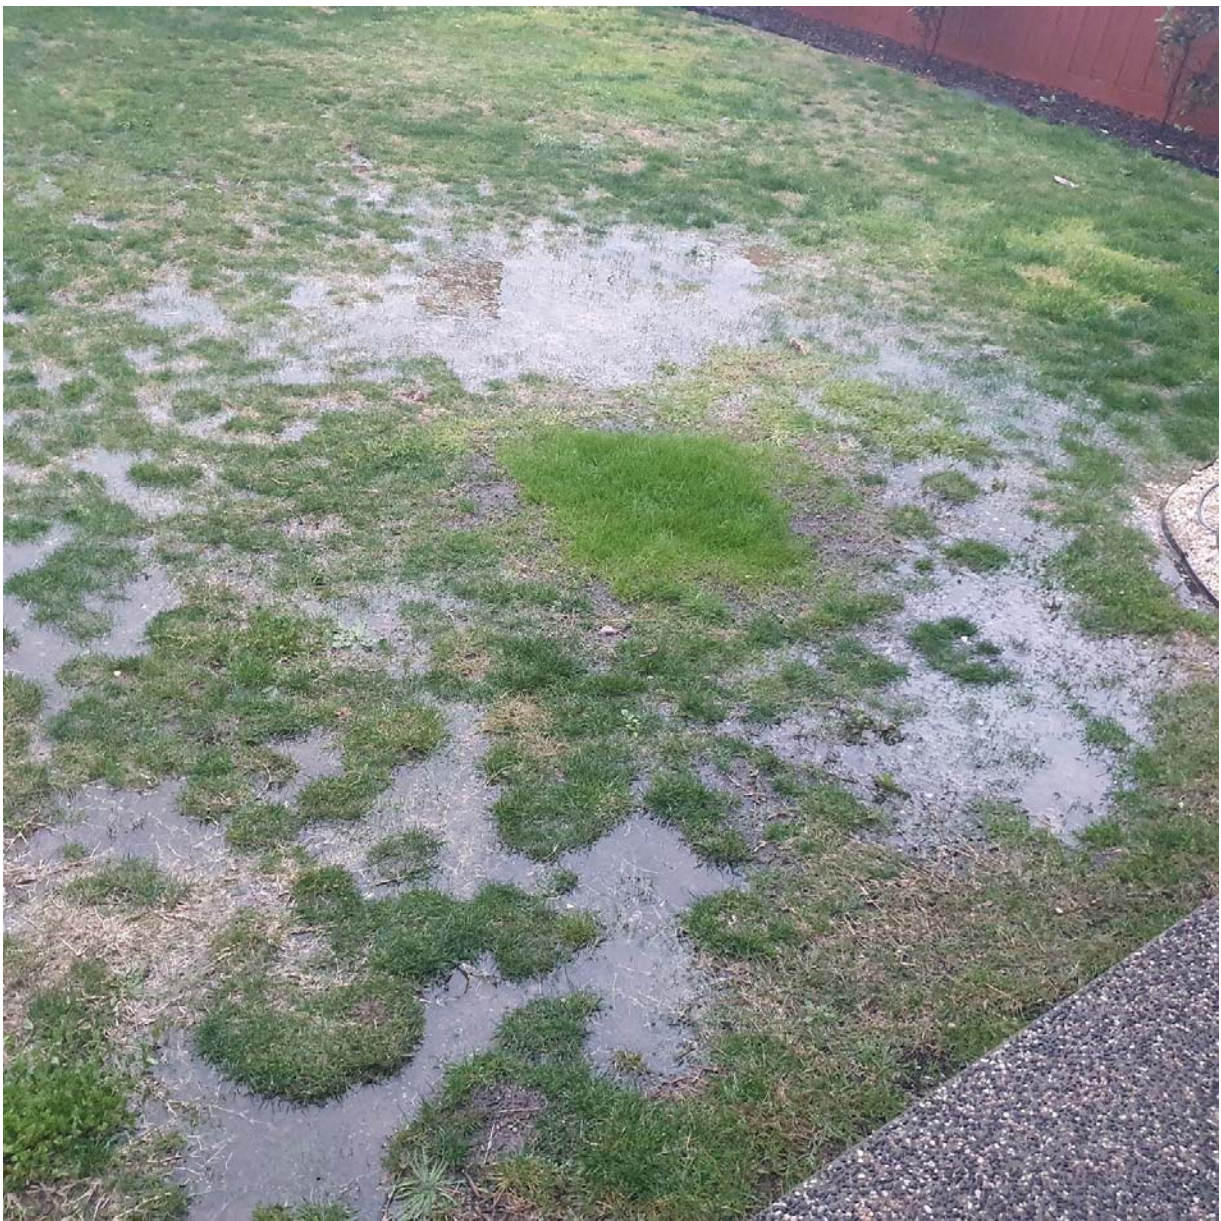
Attached you will find photo/s to support the continuous backyard flooding. Every time Torquay is subject to one day of heavy rain or a couple of days of light rain, our backyard is subject to flooding due to the extent of moisture still evident in our soil. This is despite us adding additional drainage to our property, as advised by our builders, due to dam flooding prior to our build. Please refer to Geotech results and evidence provided in initial submission to corroborate this.

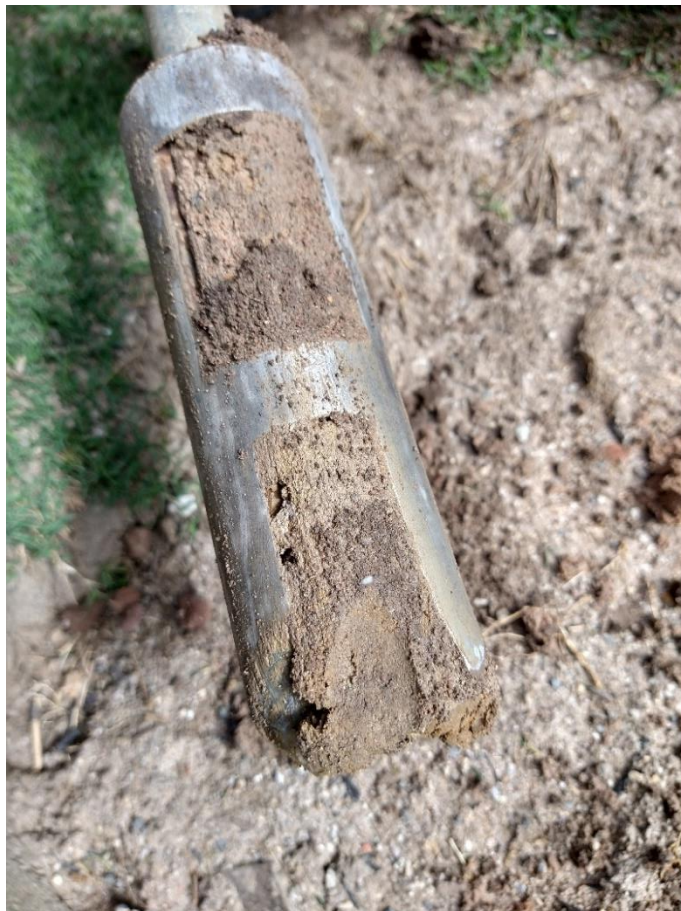
**Photograph 1: Silty Sand and Silty Clay Layer from HA02**

During the intrusive investigation, observations of the natural silty sand layer encountered between 0.25 m and 0.7 m in HA2, HA3 and TP02 showed this material to be wet compared to the same layer in HA01 where it was recorded as moist.

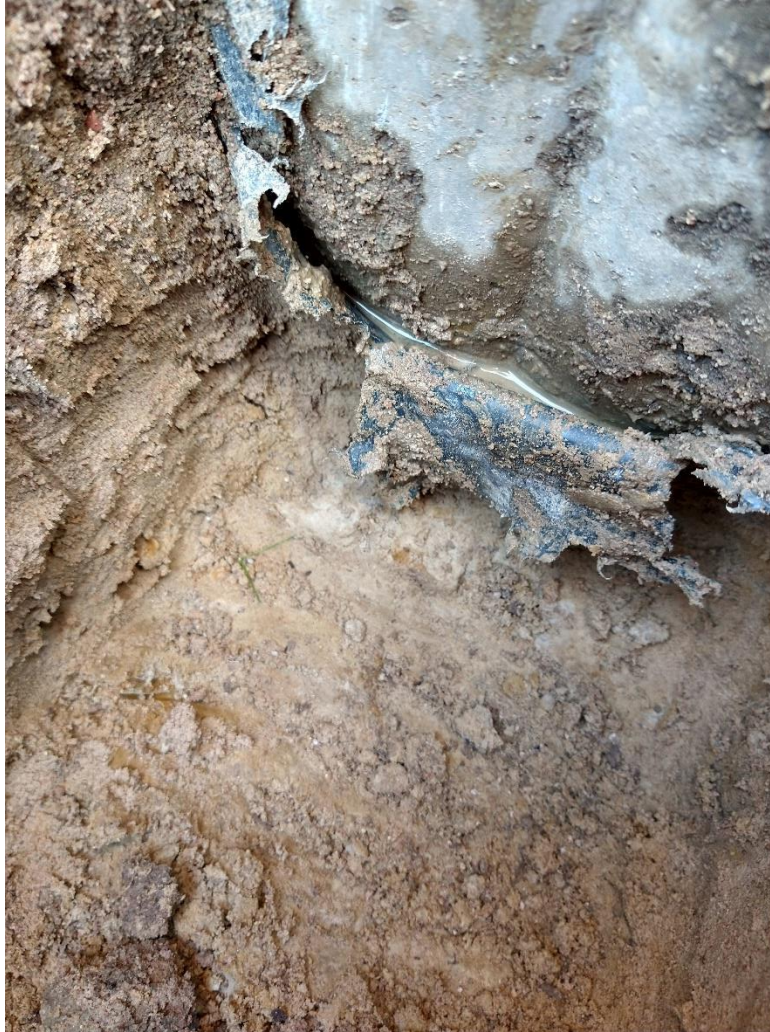
**Photograph 2: Base of Silty Sand layer Against Slab Footing**

Hand dug test pit TP02 was carried out against the slab footing of 63 Pintail Drive. From 0.4 m depth to 0.6 m depth the silty sand encountered was saturated (see Photograph 2).

Further advice should be sought from a structural engineer to assess the slab footing condition.

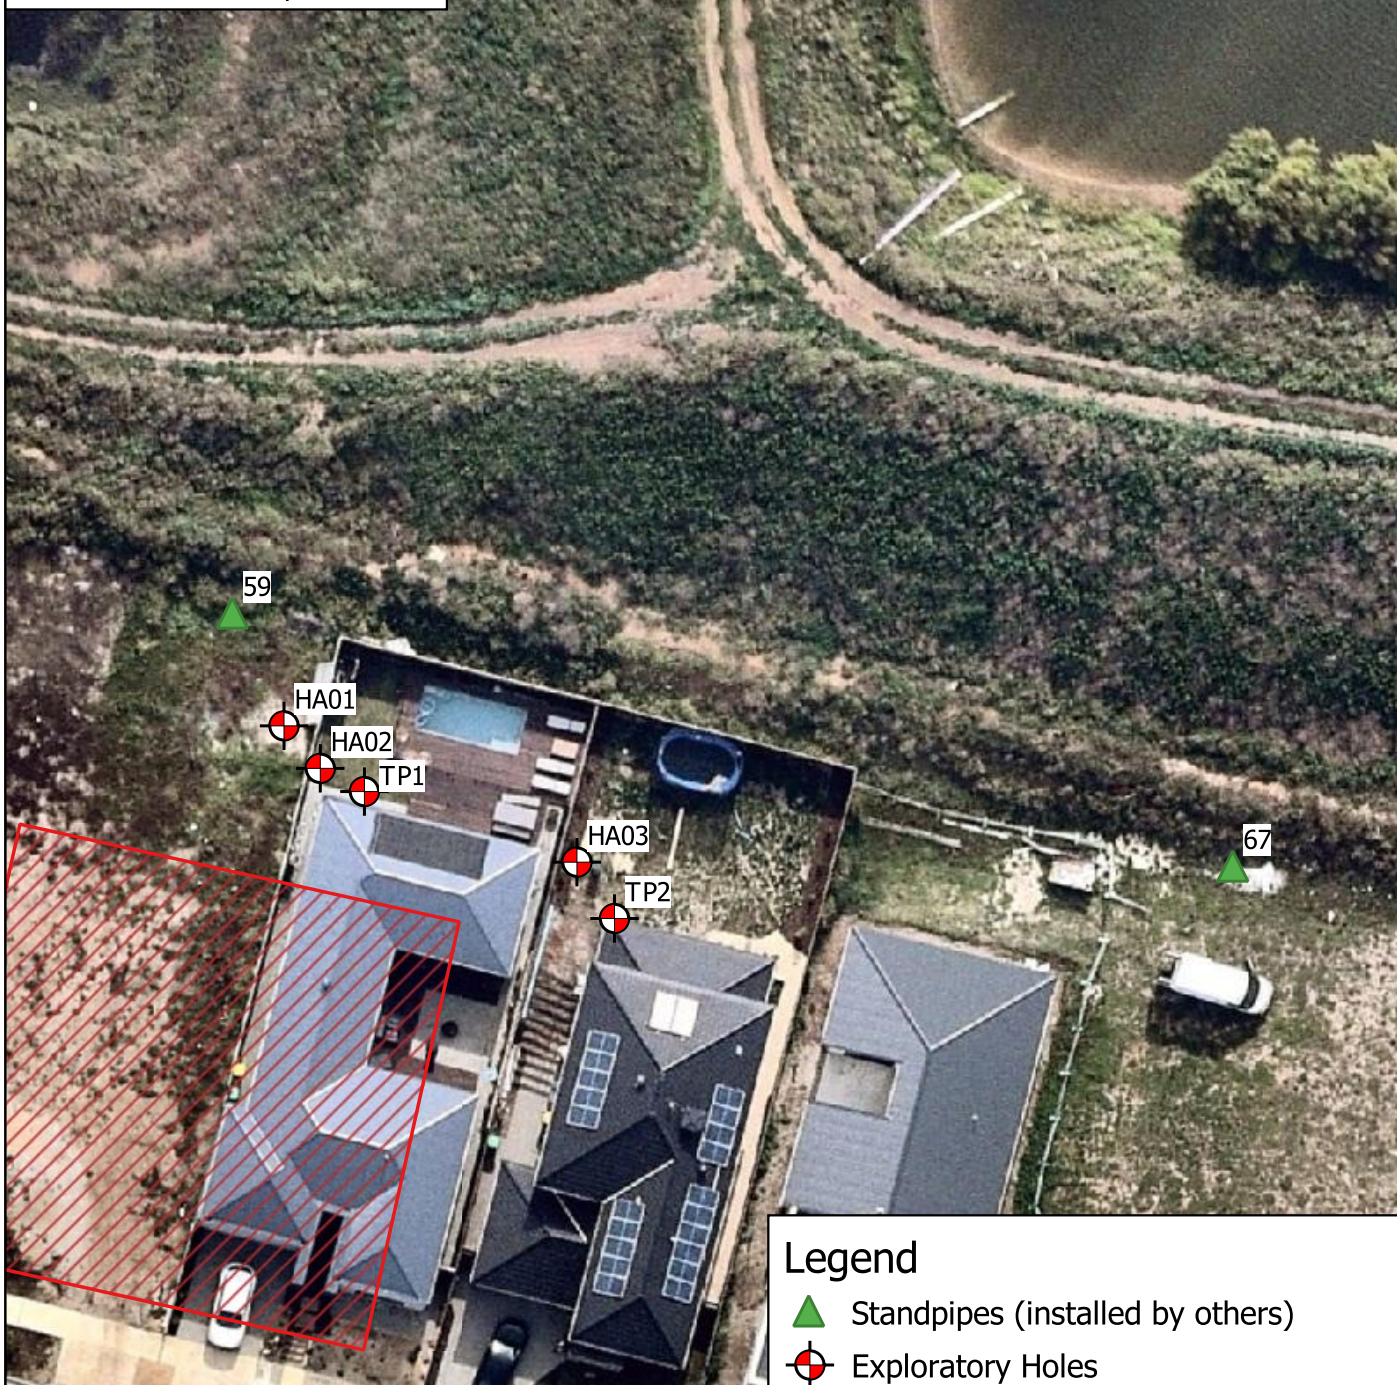
The fieldwork was carried out on 16 November 2020 and comprised three hand auger boreholes and the excavation of two hand dug test pits. (See Exploratory Hole Location Plan attached).

During the initial office-based study and site visit it was noted that the footprint of an old de-salination plant was located over the properties of 59 and 61 Pintail Drive. The plant is evident in aerial images from November 2009 and the extent of the footprint is shown on the exploratory hole location plan attached. The location and presence of the associated pipework is unknown, but it should be noted that disused in-ground services and backfilled alignments of removed services can potentially act as conduits for seepage flow.
