## Arboricultural Impact Assessment

Tree/s Location: 1075 Horseshoe Bend Road, Torquay, 3228

Completed for: Santo Spirito Flowers

Inspection date: 28<sup>th</sup> January 2021

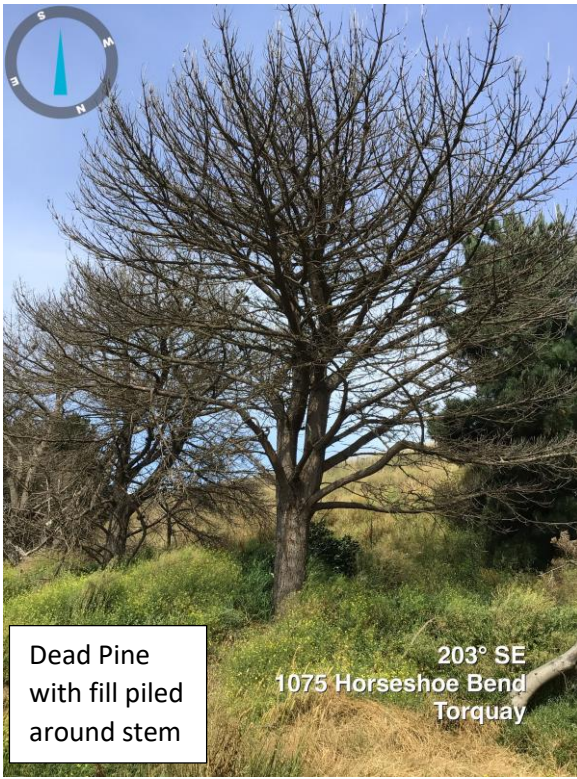
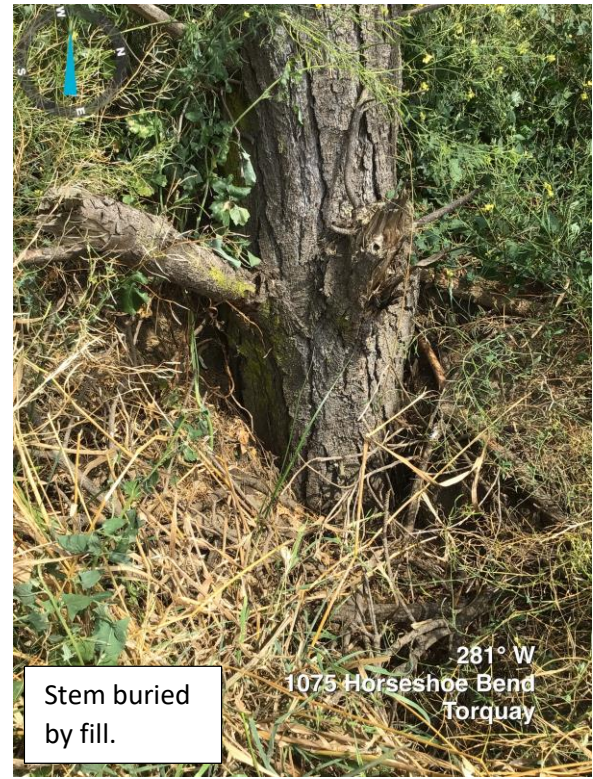
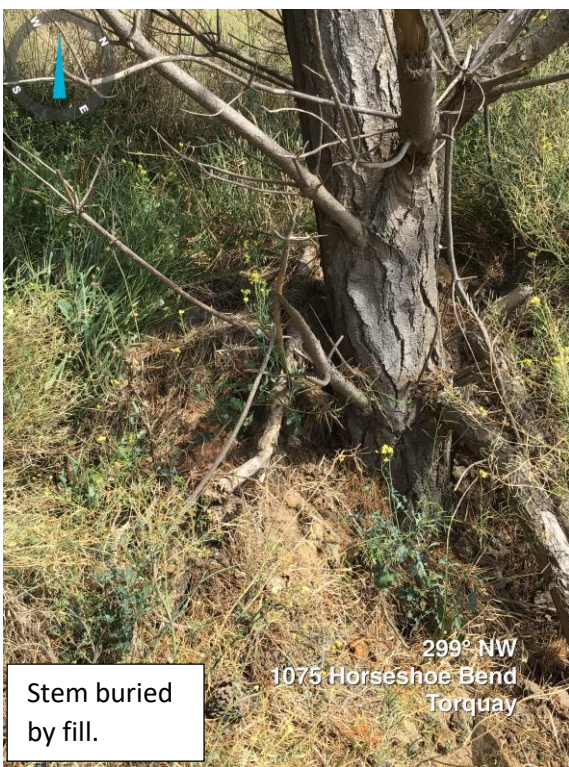
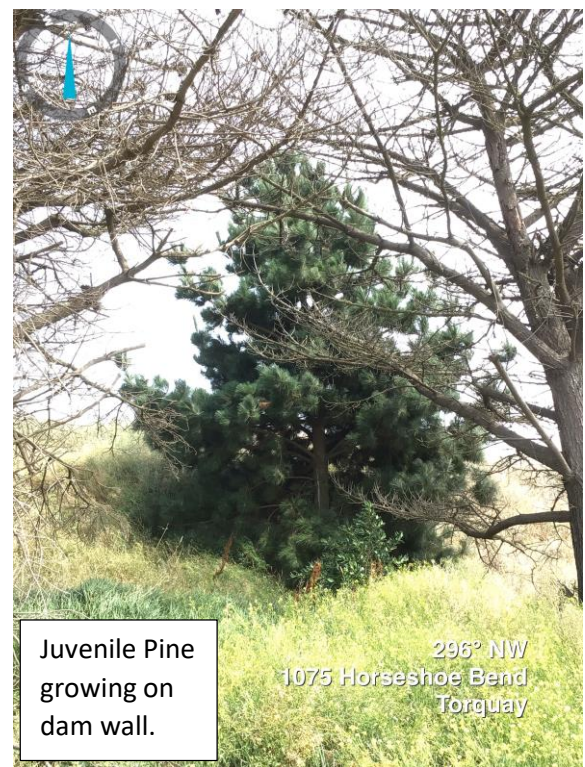
3. All dead Pine trees and those in decline have had fill (mud) dumped around their trunks and critical root areas. This has caused their death through 'suffocating' the root zones.

Soil/fill dumped  
around root  
zone of Pines.

*This is what has occurred on this site.* Excess fill has been dumped over the dam wall and has run downhill to rest among the root zones of multiple Pine trees. Given it was likely wet soil when applied, this fill has effectively blocked any oxygen from reaching the roots, as well as preventing future surface water uptake. This has caused six Pines to die, while others are heavily declined and will likely die also.

5. We recommend fill should not be placed near the root zones of any trees on site in the future. This is extremely detrimental to tree health.
6. We also recommend any juvenile Pine trees that have self-seeded on the dam wall (see image page 9) should be removed. These trees do have the potential to damage the dam wall as they grow larger.
