Technical File Note – Assessment of Groundwater Levels across the Northern Boundary

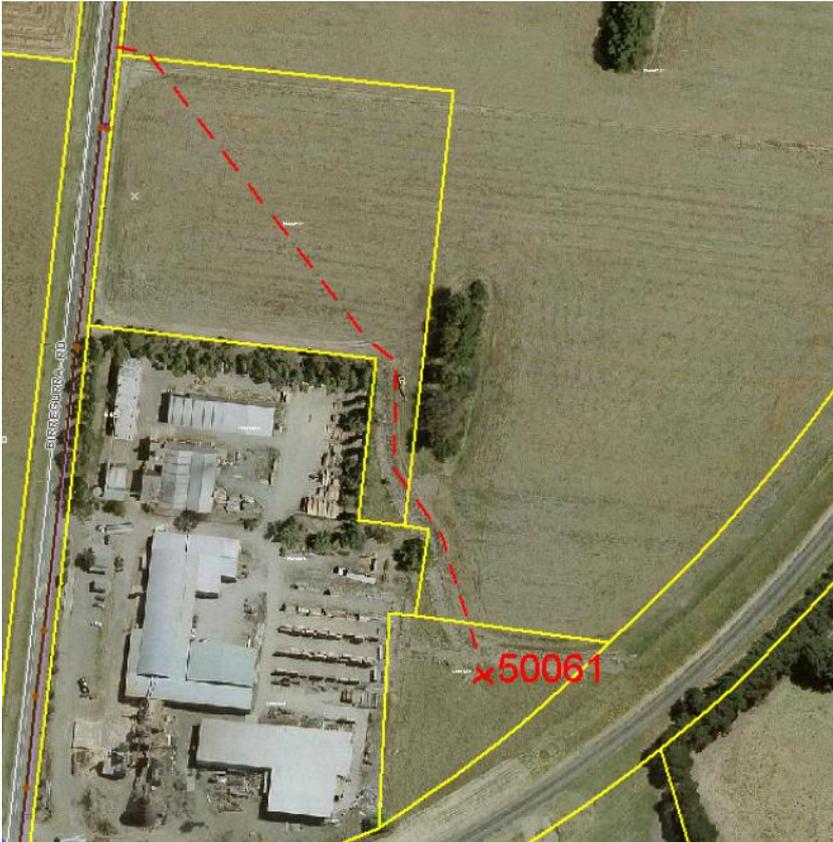
Figure 1 Location of bore 50061

It was determined that bore 50057 no longer existed and has not for many years, while bore 50061 remained beside a track bordering the Forest Timber Products property. The location and access route to the bore is indicated in Figure 1 as indicated by the landowner.

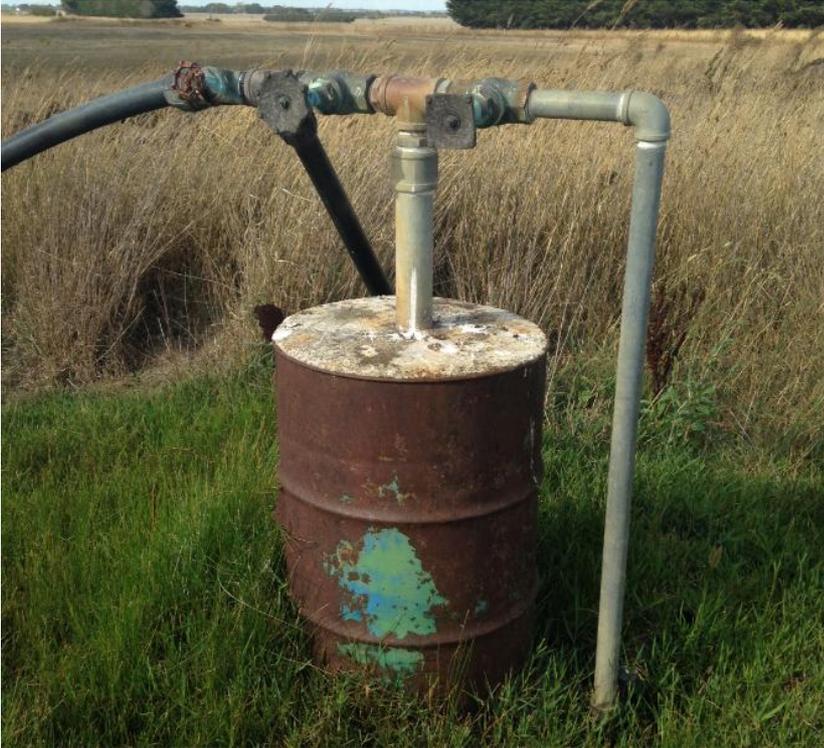
Figure 2 Headwork of bore 50061

The bore head works consisted of a galvanised pipe approximately 50 mm in diameter held by a concrete filled 40 gallon steel drum (Figure 2). The pipe is connected to a network of 3 outlets controlled by 3 taps.

Given the bore is artesian and currently in use, the bore cannot be used as a monitoring bore. However we now know that the groundwater levels are artesian at this location and this information will be used during the calibration of the numerical model.

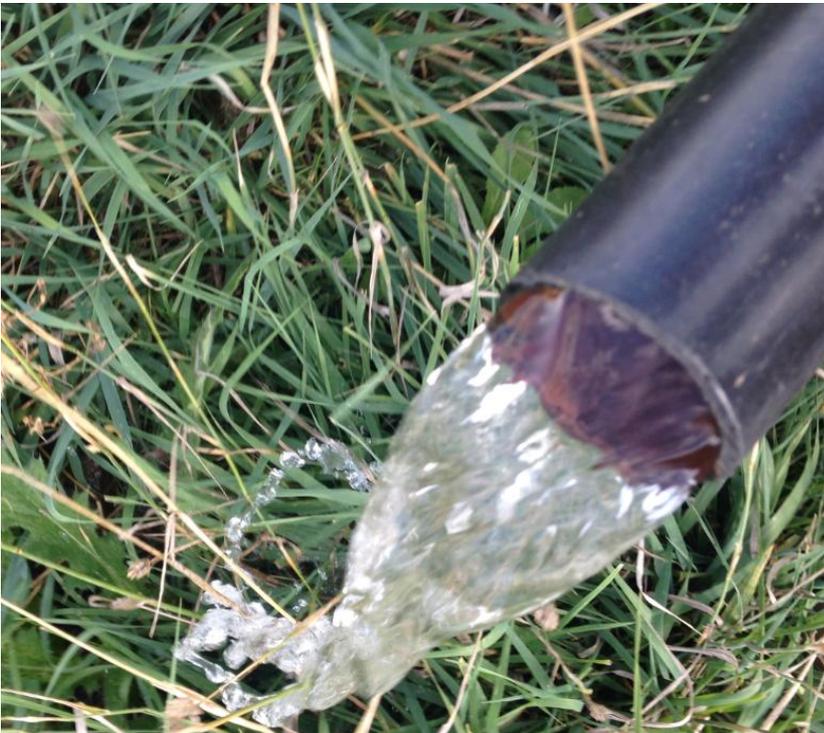
Figure 3 Flow from bore 50061

Full release of one outlet generated an unrestricted flow of ~0.5 L/s from one of the hoses. This indicates artesian conditions (i.e. groundwater levels are above the surface) at a depth of ~350 m at this location.

Landowner engagement and site investigations have confirmed the presence of bore 50061 as indicated by online databases (VVG, 2016). The ~350 m deep bore was confirmed to be operational and generating artesian flow at a rate of ~0.5 L/s.
