**1075 Horseshoe Bend Road,
Torquay, 3228
Farm Dam Existing Conditions Survey**

Municipality: Surf Coast Shire	Coordinate Datum: Scale A1	5	0	5	10	15
Drawing No. MGA94 CRD	Scale: 1:500	Lengths are in metres				
Map Ref: N/A	Sheet: 1 of 1	Version: 1				
Drawn By: PM

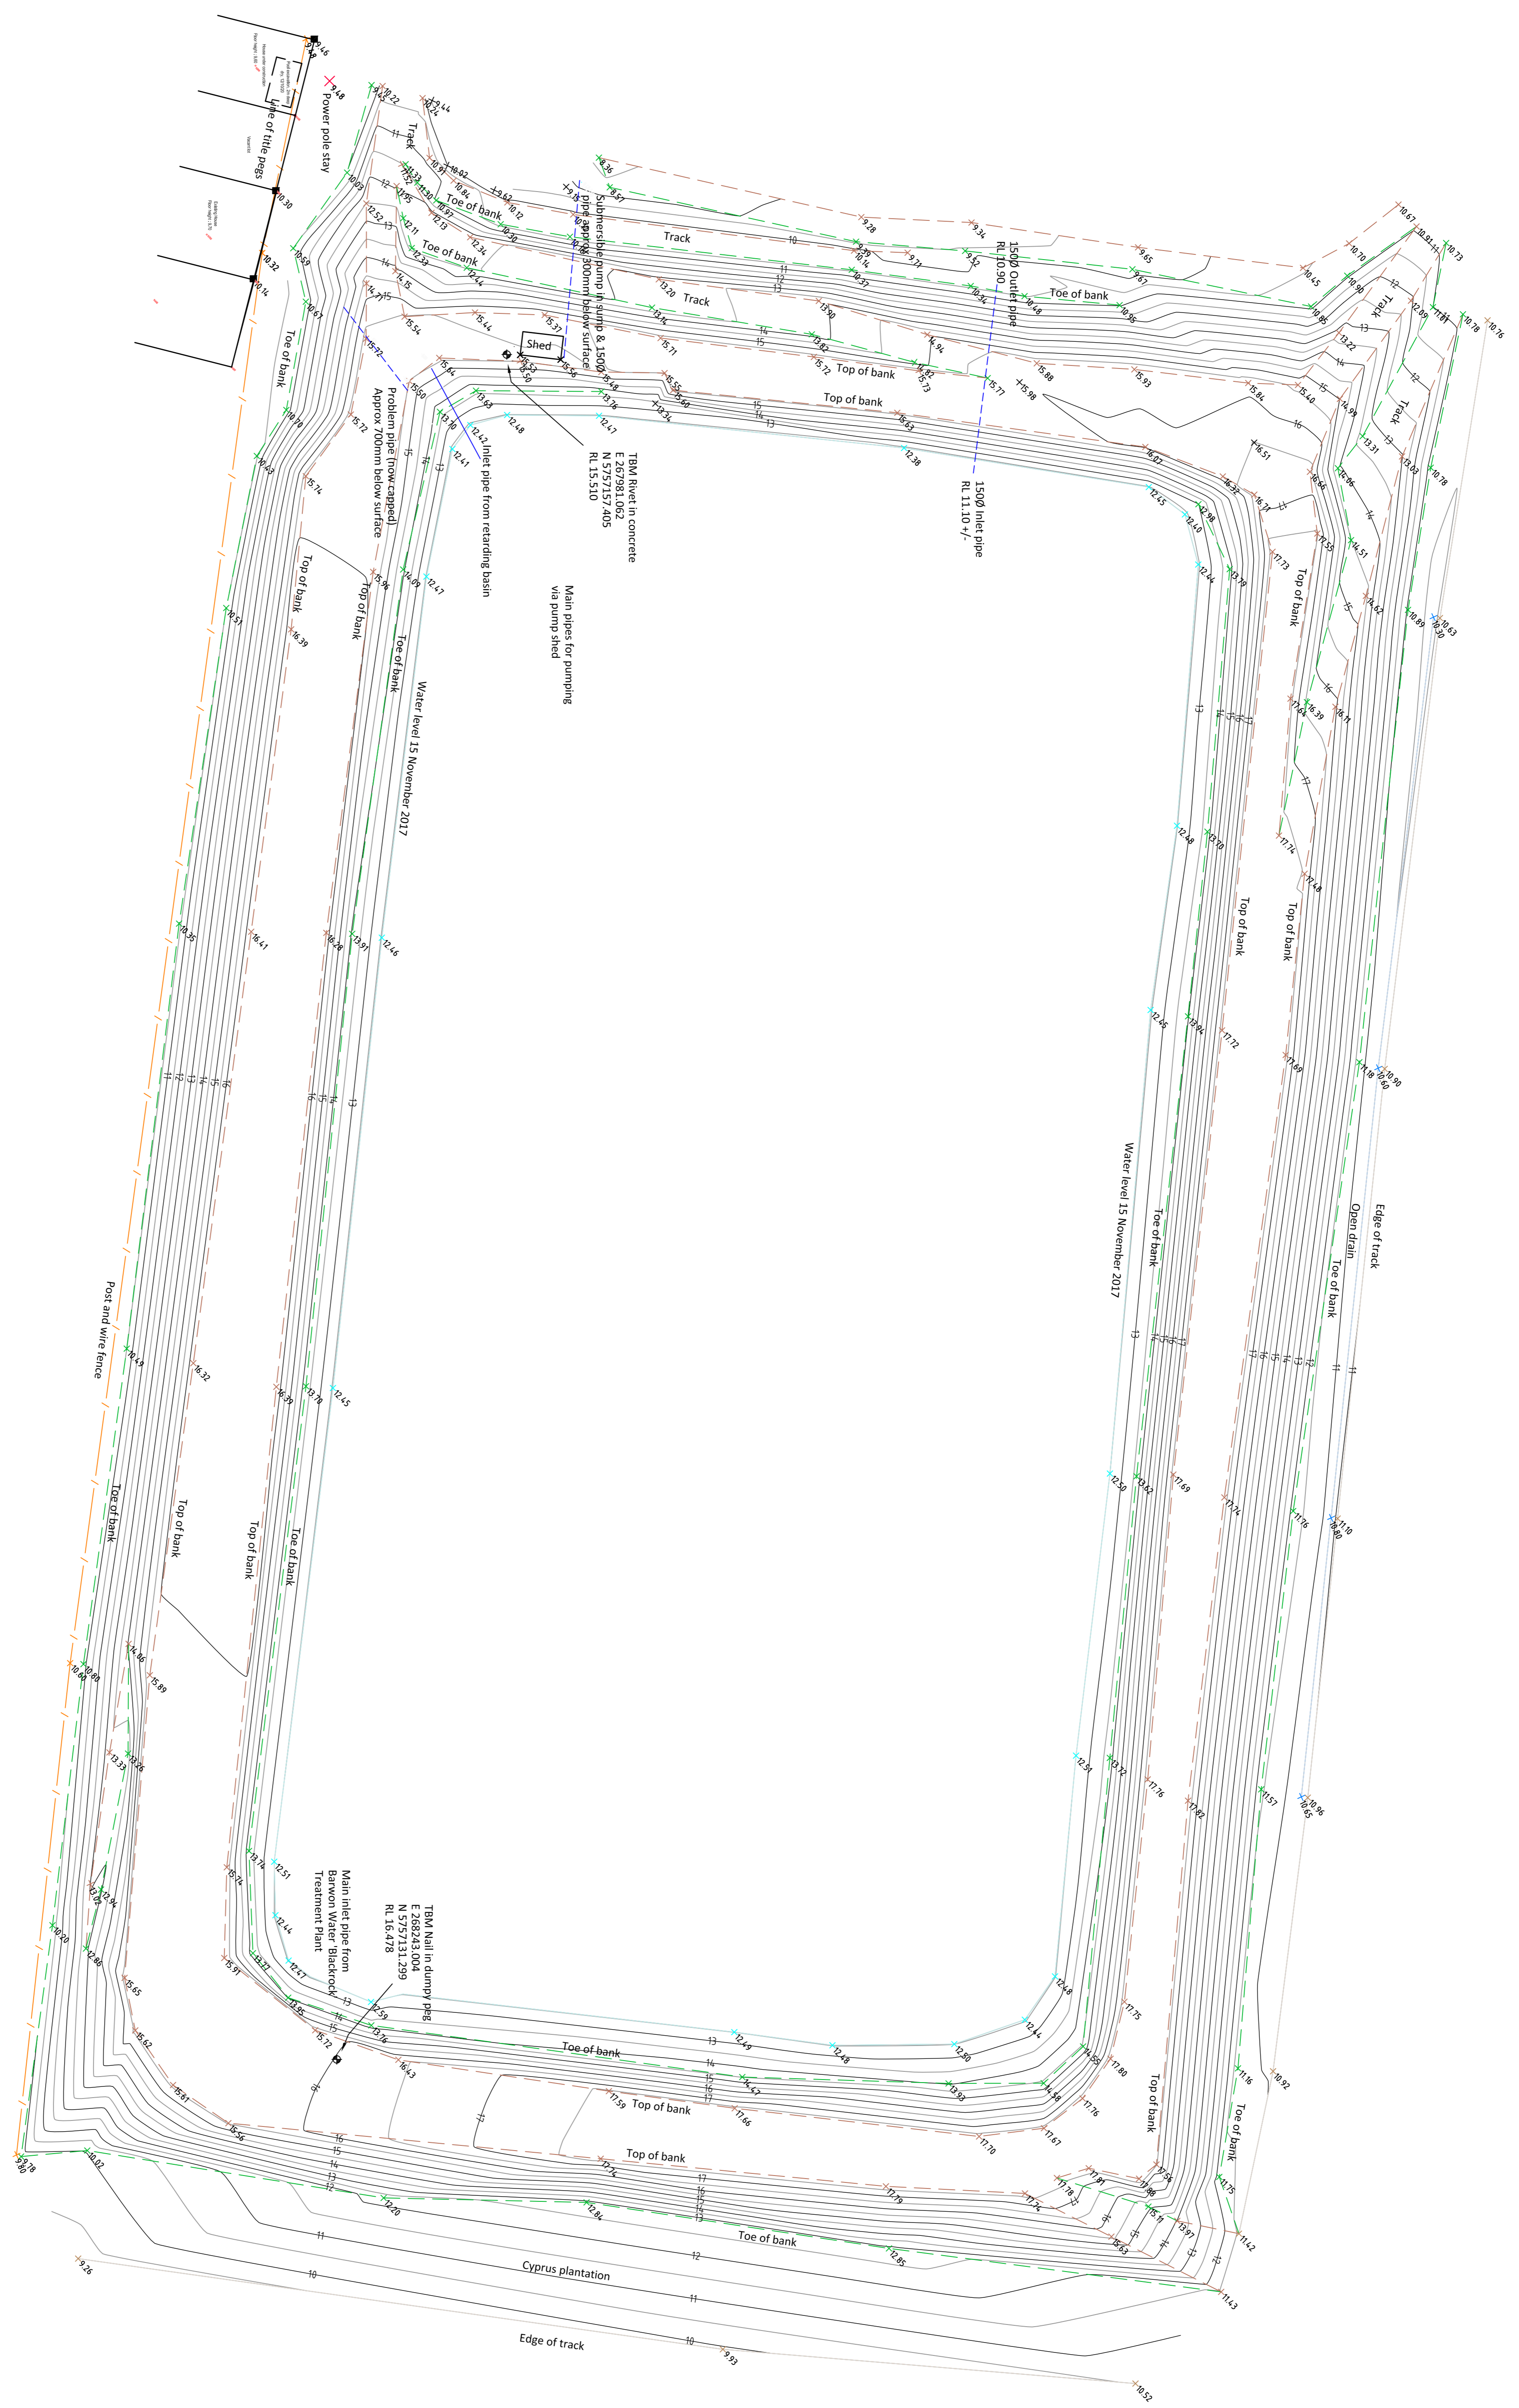
Measurements are in metres.
Levels are to A.H.D. based on PM 71, published R.L. 16.054 metres.
Co-ordinate datum based on GPS Net solution, checked against Pucka PM 71.
Contour interval is 0.5 metres.
Surveyed 3D triangles are on layer 'TO_SURE_TRIANGLES_3D linework of relevant feature have the suffix "_3D" to the layer, all of which are frozen for clarity.
Features and levels shown on this plan are for general design works only - any other features shown are for information only. No liability is accepted for any demolition, excavation or construction on this site. The relevant authorities should be contacted to ascertain detailed locations of all existing services and the possible locations of future services.

Class 'C' re-cycled water from Blackrock treatment plant (Barwon Water)
One week pumping results in an increase in water level of approximately 1.25m
Relating basin inflows are recorded @ 143.628m³ from 9/05/2019 to 11/08/2021
That is 27 months @ 5.3 megalitres a month, or, 1.18 megalitres per week.

@ water level 12.0m - 27.673m²
@ water level 13.0m - 30.201m²
@ water level 14.0m - 32.279m²
@ water level 15.0m - 33.614m²

Earth in embankments came out of the hole : Approx. 80,000m³
About 0.5m cover placed over the bottom of the dam.
Natural surface level : Approx. 10.0m AHD
Estimate of bottom : 6.5 - 7.0m AHD
Volume @ water level 13m AHD : Approx. 140 megalitres
Volume @ water level 12m AHD : Approx. 115 megalitres
